Restoration of a Broadwood square piano, 1793

Thomas Strange – Jan 2010

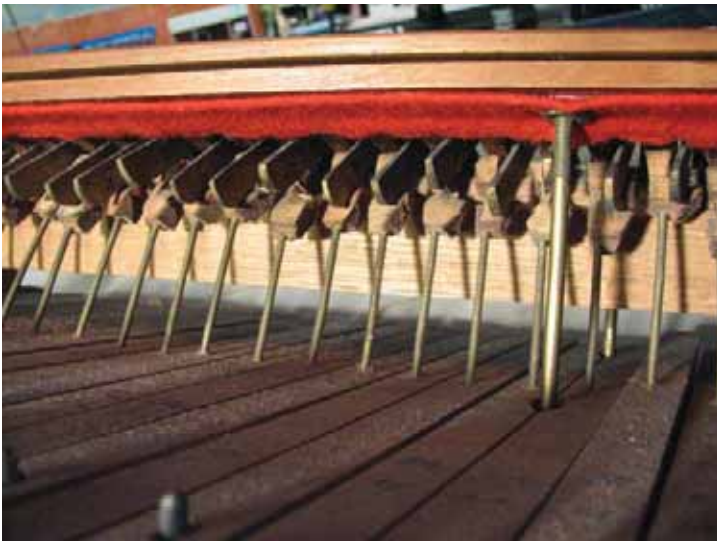
Modern felt has replaced the flannel that the damper counterweights once contacted, but it is serviceable and out of sight, so left alone. Each damper lever pivots on a brass stanchion with an iron axel allowing it to move freely though with a fairly close tolerance. Over the last two centuries, various oils, including undoubtedly whale oil, was applied to make the pivot freely. Over time, these oils oxidize and break down into fatty

acids, attacking the brass and producing the characteristic deep green verdigris, with polymerized oil chains making up the body, and producing a stiff thick gel which causes the dampers to pivot slowly or not at all. On warming, the joint will actuate, but becomes stiff again at room temperature.

Short of total disassembly, the best way to clean these pivots is by use of a multi solvent non-polar mixture that can dissolve and clear away residual fatty oils and etc. The product Goof-Off contains a suitable mixture at low viscosity to accomplish this task. Goof-Off is applied carefully to the joint, the joint worked back and forth, and using a high pressure air hose the joint is blown clean, and the operation repeated until the product removed is clear. The hammers and all action parts and framing are covered to do this. Since the stanchions are cemented into the frame removing them all was deemed too invasive at this point, so all cleaning was done in-situ. Once the damper pivots freely, a stable oil such as Liquid Wrench L204 is applied. These will not oxidize quickly and should provide decades of trouble free service.

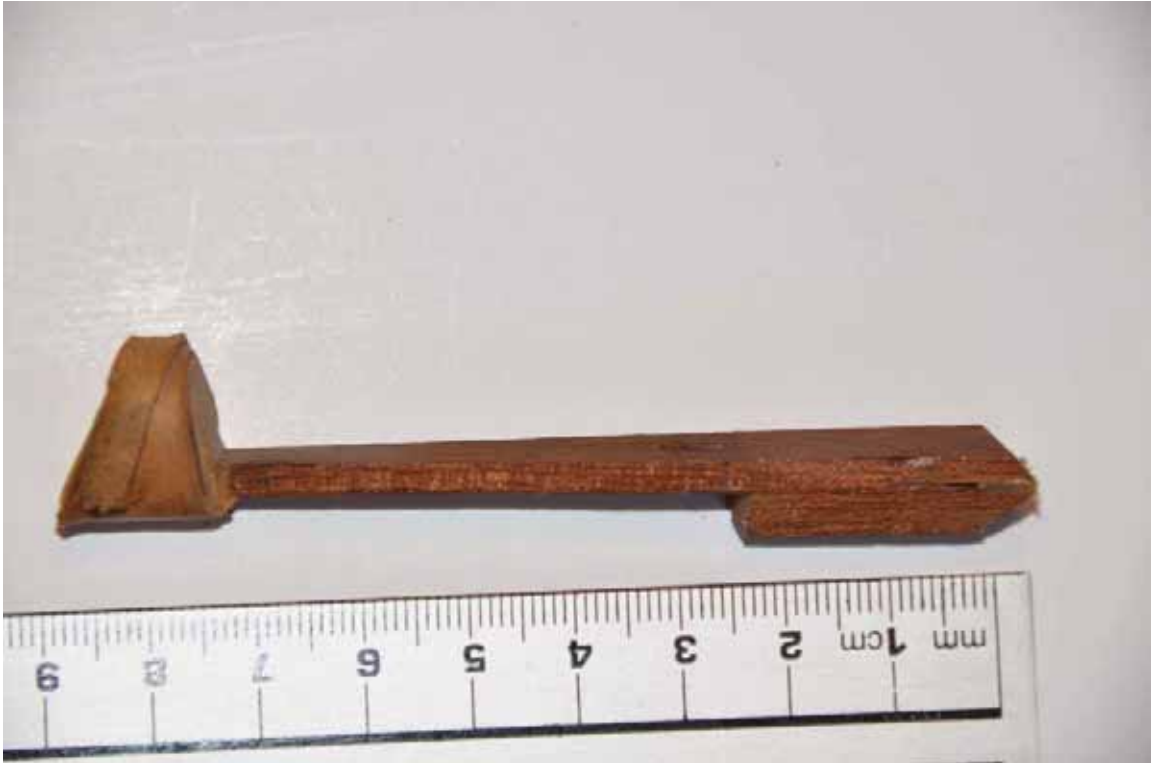
The lowest bass hammer (FF) was broken at the hinge. The end was soaked in very hot water to loosen the glue and the remaining leather slid out. New goat skin was shifted into place and glued, then the flap trimmed and glued to the hammer rail. The hinge should stand just proud of the edge of the hammer rail by about 0.5 mm to 1.0 mm but no more, or the hammer will have excessive play on actuating.

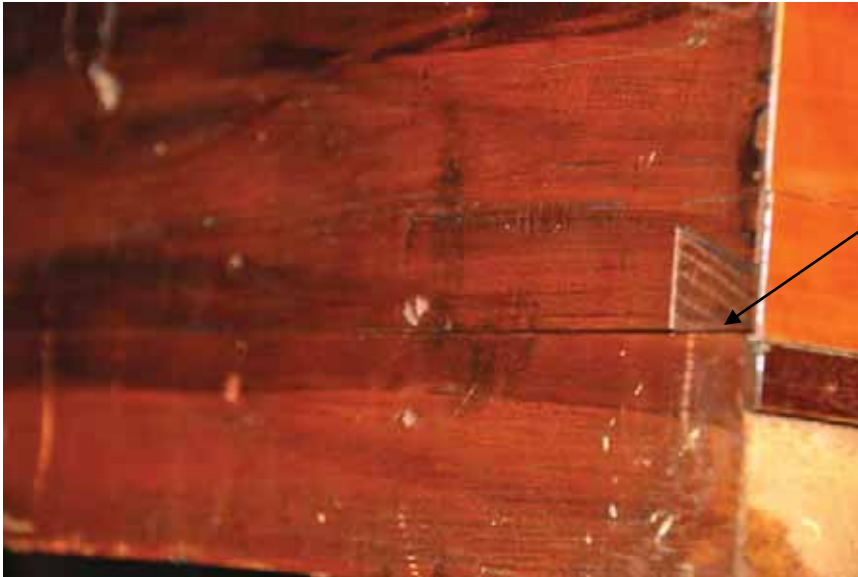
The case is mostly intact with the left side showing some parting with the baseboard in the left rear corner. This was to be repaired as described.

Gap to be repaired

The gap was washed out with hot water shot from a syringe until the water ran clear. Hot hide glue (Luthiers Mercantile Int. FHG #192 gram strength) was liberally injected and the case was clamped to close the gap, and excess glue wiped up. The clamped case was allowed to sit 48 hours, and while still under the clamp, three holes were drilled for 4 inch stainless steel screws, which were given a pilot hole into the case, a through hole of the baseboards, and counter sunk to clear the head. The screws were driven in under torque to 5 ft-lbs. The screw acts as a lateral anchor to keep the case from shifting and breaking the glue, but the glue does all of the bonding of case to bottom boards.

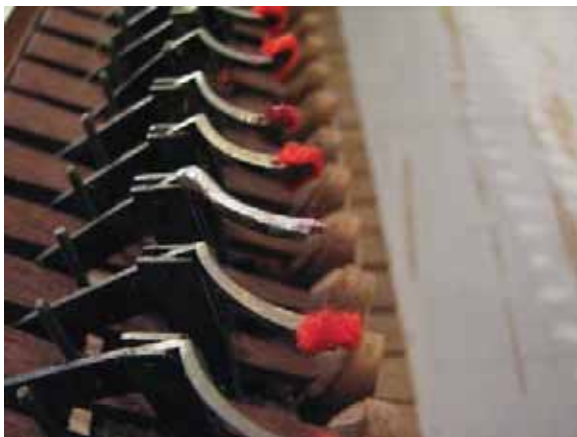
As described earlier, repairing the dampers consists of careful work to loosen the old flannel, move more active flannel back into play, or replace it entirely. Broken arms and clasps were replaced with newly cast parts made by David Law of Traditional Brass.

Replaced damper arms were cut to length and height and inserted into the original pinion stands. Damper arms need to be a few thousandths thinned than the pinion stand slot, and a little oil will quiet any that are slightly too loose. Slots more than about 5 thousandths must be squeezed tighter and adjusted for easy travel of the damper. As many original dampers were left in place as possible. For two, an additional pad was cemented over the remaining tuft, to avoid possible breakage during replacement of an otherwise well operating arm.
