# Restoration report

## South German or Austrian Tafelklavier c. 1830-40

Andrew Nolan, Broadbeach, Queensland. copyright 2011

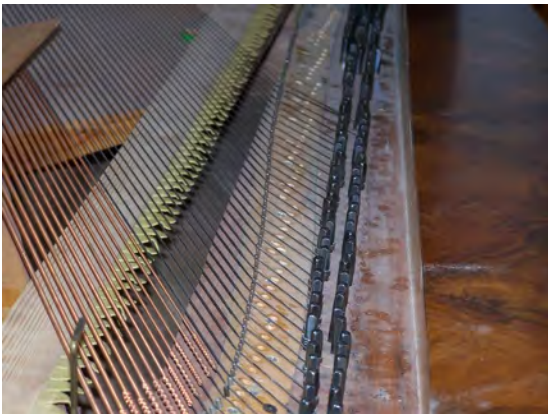
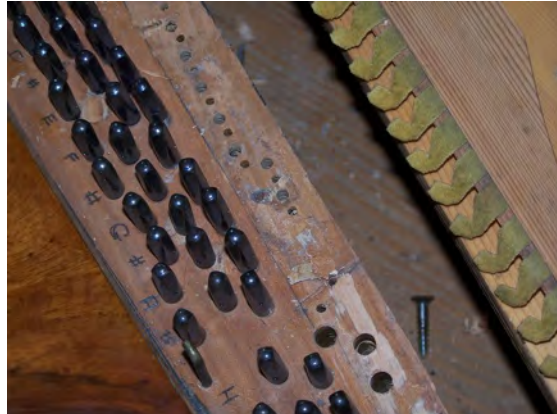
The instrument has about 1" of twist when strung. This may have existed since manufacture as the leg blocks attached to the baseboards are of different heights to allow the instrument to stand flat on the floor. The cabinet work and veneer is in good condition and appears to have been retouched in places after repairs in the 1970s. The legs of solid walnut have some woodworm damage and the front right leg probably requires further consolidation. The damper rack is in good condition but the damper material is modern wool felt. The strings are modern patent piano wire several sizes too heavy. The pinblock is a poorly made replacement from laminated material with a layer of cheap plywood underneath, it has been installed by cutting the yoke at either side of the keyboard and partially removing the old pinblock from under the yoke. It was fastened in place under the yolk and at each side with carriage bolts, also glued with PVA.

The stringplate and soundboard have been removed in the process, damaging the internal veneer at the back right corner. The soundboard and bridge appear to have been disassembled to some extent and rebuilt using PVA glue. There is a metal plate sandwiched between the pinblock and yoke at the treble which has been cut at the back, possibly removing some extension that might have been there.

The replacement pinblock is too thick and has been crudely cut out underneath to accommodate the damper stools. In addition when the old nut was glued back (crudely) the stringband was too high and the damper rack was out of alignment. They repositioned the pivots to overcome this but the dampers still functioned poorly. Because the stringband was too high the hammer let-off could not be adjusted to make the action function reliably with soft playing. Examining the pinblock underneath showed that they attempted to re-use the holes in the nut for the damper stickers but had to have several goes at realigning the nut resulting in multiple sets of holes being drilled through the pinblock. The pins used to replace the original pins if they existed were large size grand piano pins which were crudely positioned, not in line and drilled at various odd angles.

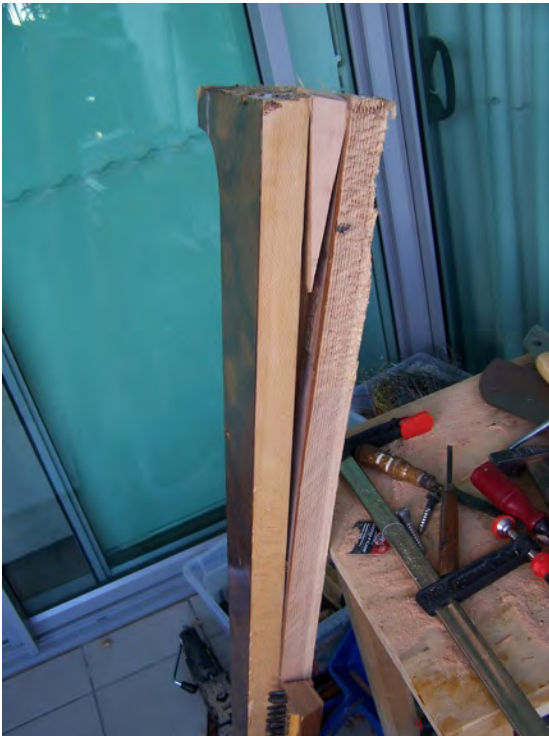
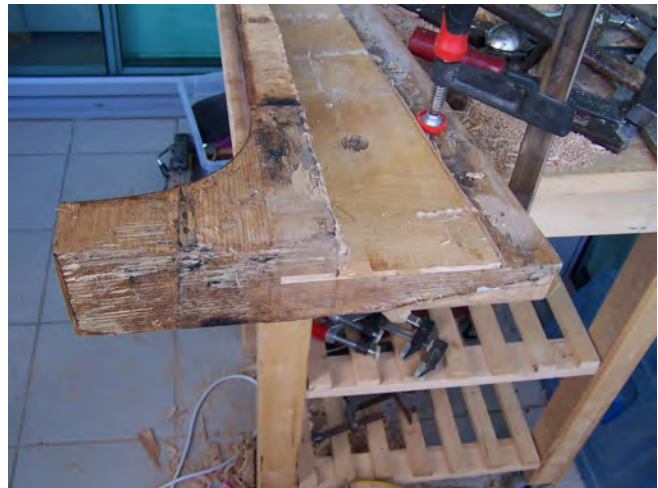
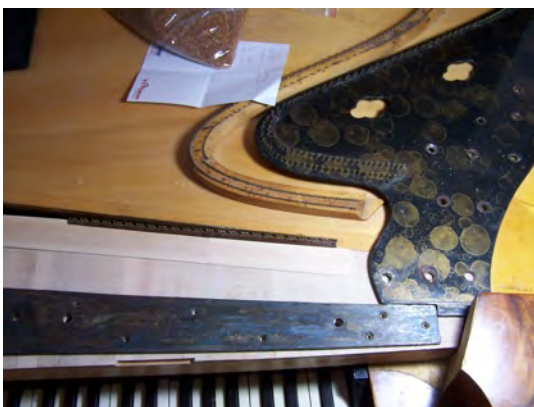
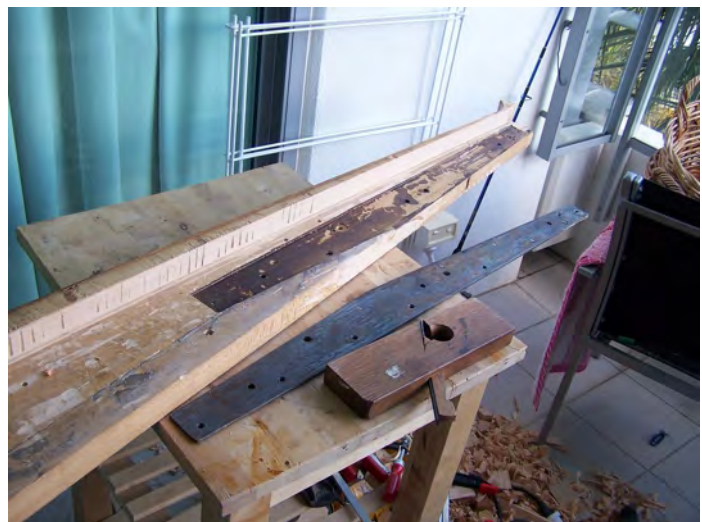
heads. It is possible that some of these might be original and they were saved for re-use. After they were removed, the pinblock came away very quickly using a chisel and wedges. A metal surface or lamination was apparent in the treble, it had been cut where it passed over the visible surface of the pinblock with a rotary cut-off wheel. It was found to extend over half the length of the yoke and was fastened to the pinblock with 1 " screws. The pinblock and yoke were additionally fixed together with bolts passing through into captive nuts under the veneer on top. One bolt was not able to be removed and a small square of veneer was 'popped' out to access the nut. The replacement pinblock had had only 3" of gluing surface width with the yoke and a more substantial replacement was considered necessary. The thicknesses of the pinblock laminations could be deduced by examining the remnants contained under the yoke. A new pinblock blank in beech was prepared and

fitted into the case. The gap position was worked out based on the hammer strike line and carefully cut out and the gap left a little too far back initially. Hard maple capping veneer was sawn and planed to thickness and glued in place across the plank.

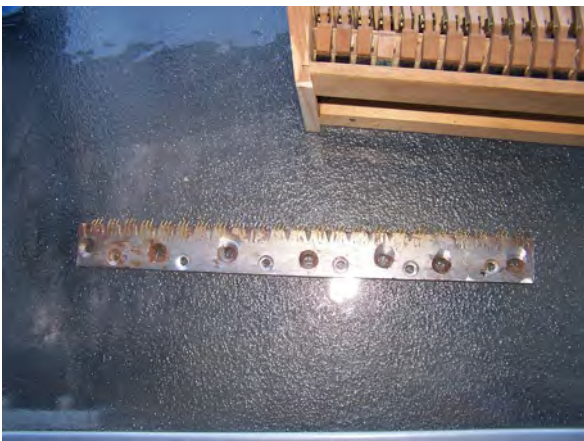
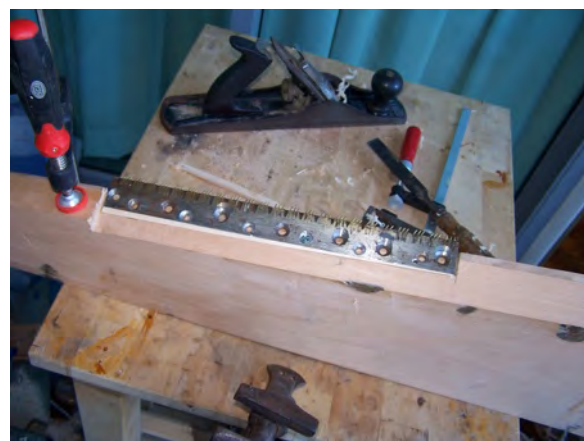
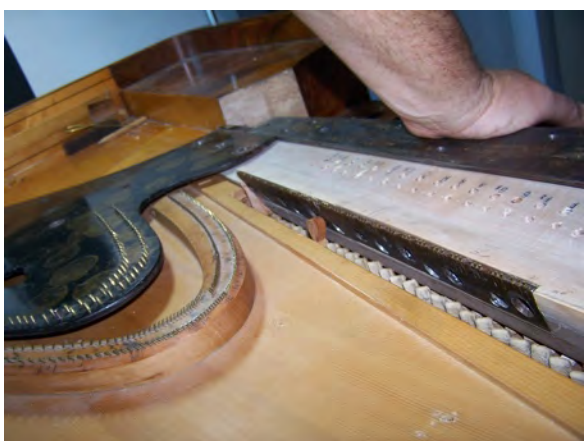
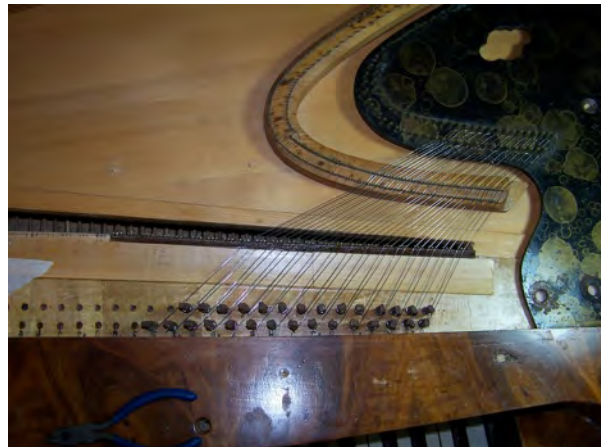
Some discussion and thought was given to reusing the metal nut section and whether to re-adopt trichord stringing in the upper register of the instrument. The metal section has had extra fixing holes drilled in it but the pinned section was serviceable. It was unlikely that this piece would survive longer term if not re-installed. While bichord stringing is easier to tune and has a less complex sound than trichord, in the treble with thinner strings it is easier to overcome the elasticity of the strings with heavy playing resulting in a dull sound. Most pianos of this type used trichord stringing in the treble, particularly as time went on. On a practical note, it is easy to reduce trichord to bichord by simply removing strings, but to reinstall a section of the nut and layout and drill for more tuning pins is considerably harder! The original nut was reinstated, after a 7 mm recess was chiseled from the front treble section of the pinblock. The nut was chalk-fitted to the recess and some lateral leeway was allowed for. The nut was fixed temporarily in position and test strings were used to check its location. Finally it was glued and screwed into position and a small wooden plug filled the gap in the recess on one side.

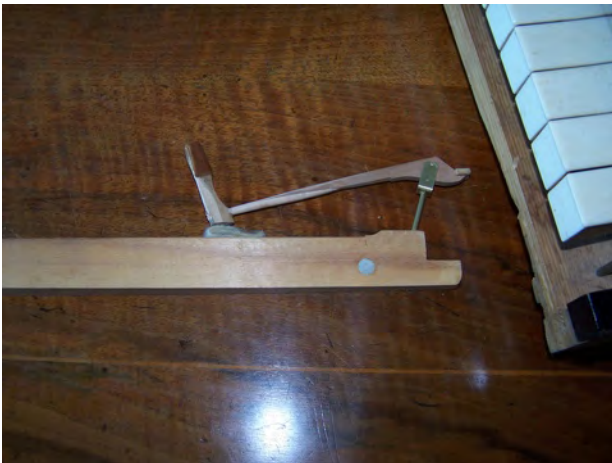
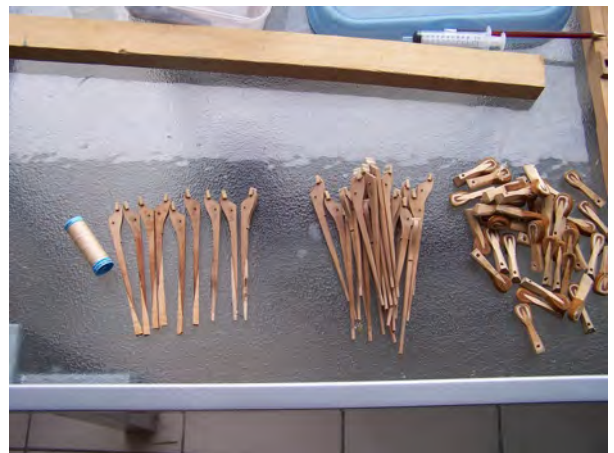
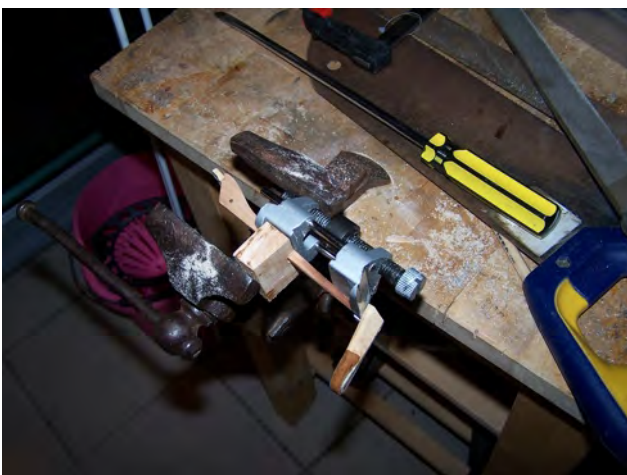
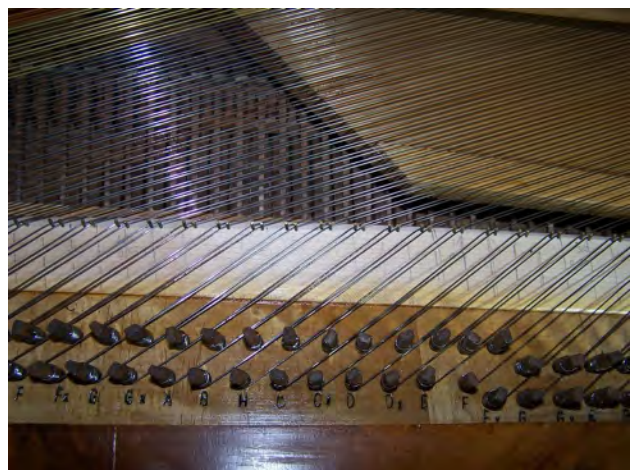
At this point most of the hammers contacted their correct string pairs but about a 1/3 needed adjustments to the hammer head positions and another 1/3 had had poor hammer shank repairs. First the balance punchings and back rest cloth were checked, then the kapsels were inspected for any bending and the line of hammer beak leathers was checked to make sure it was straight and level.

The hammer heads and bad shank repairs were loosened by carefully soaking the joints in a shallow tray on an incline (actually a plastic dustpan!), avoiding getting the leather heads wet. After 4 or 5 hours the heads were sat on their bases on a kitchen hotplate set on low until the glue joints had heated, The joints were carefully pulled apart by a clamp adapted for the purpose from a adjustable chisel honing guide. All parts were numbered and set aside to dry. The original hammer shanks were of pear wood but this was not readily available and I chose to use maple for the replacement patches. The broken ends of shanks were planed at an acute angle to make a long scarf joint and corresponding patches were made and then glued with hide glue and bound with thread and set aside to dry. When dry the thread was cut off gently and the patch planed on a small nose plane and sanded lightly to match the original complete shanks. The shanks without heads, both original and repair were remounted in their kapsels. Successively the position of the heads was determined by arranging a series of heads on their shanks in the likely correct position, installing the action in the instrument, noting the position of the hammers relative to their ideal position on paper (as + or - 0.5 to 2.0mm), when correct, marking the head position on the shank, and finally gluing the head on.

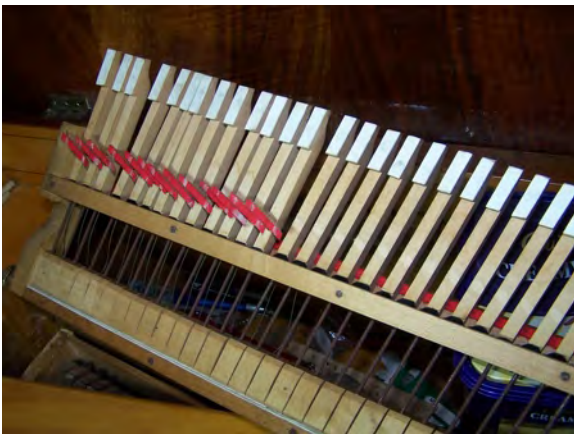
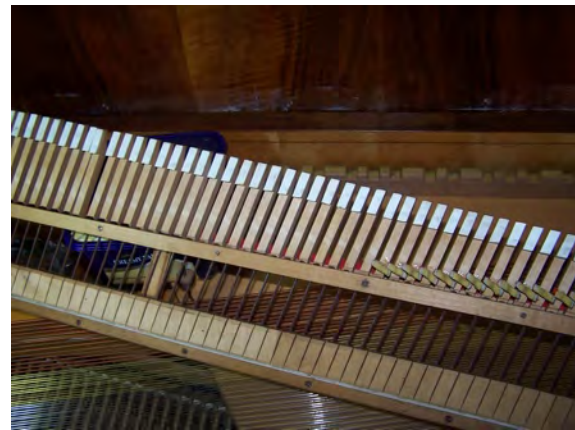
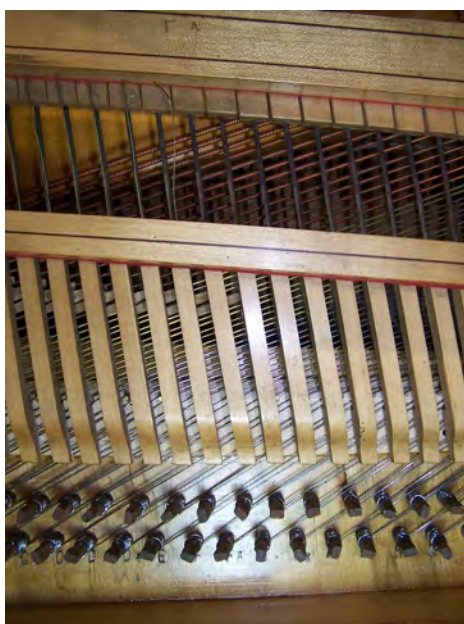
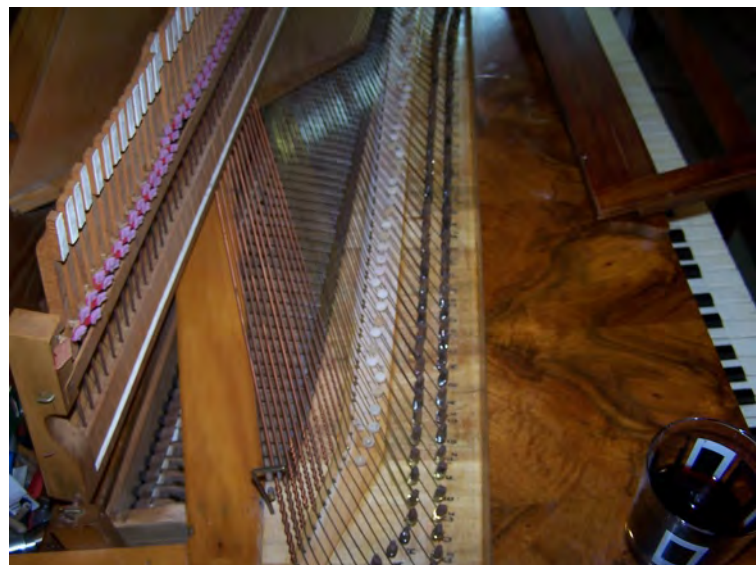
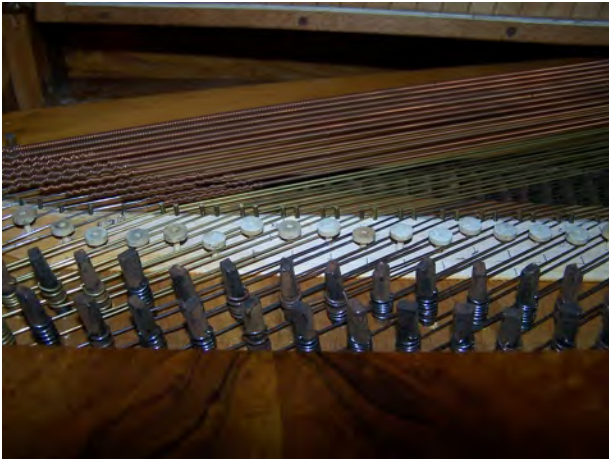
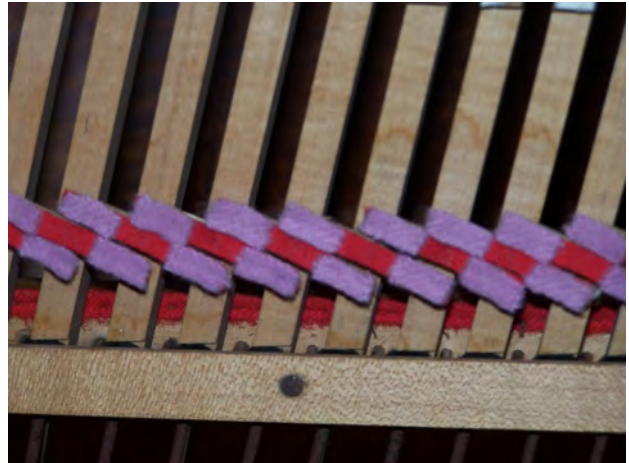
Next I turned my attention to the damper system. The damper rack unit bass side was mounted at the end of a small block originally nailed to the side of the left keywell. The treble end pivot pin sat in a hole in a metal bar and was retained in position with a small turnbuckle. This bar was cantilevered from the side of the yoke and its height determined by a pivot and adjustment screw. This arrangement is also found in later Kulmbach instruments. One tuning pin had to be relocated to clear the bar. Because the string positions were close but not identical to the original ones, dampers would have to be repositioned. In this instrument the overhead damper levers have damper mounting blocks glued to them. These blocks are tapered in height and are positioned over a string pair. The apparently original cloth strips for the treble dampers remained and were in good condition so these were retained and similar damper cloths for the remainder were made

from slightly thicker baize cloth and glued to the blocks. The blocks were carefully unglued with a small amount of water positioned near the glue joins, and reglued to sit correctly over their string pairs. The levers were pushed up by small stickers and the next task was to determine their positions and drill the holes. The original stickers were missing but a broken stem of one was found after searching through debris and dust inside the instrument. This broken stem gave me the diameter of the sticker shafts. A substitute was found - smooth bamboo skewers. The small heads were modified from piano action adjustment buttons by cutting each in half and drilling for the shaft to get the 3mm high by 8 mm dia. size required. The positions of the sticker holes were determined by marking a line on the nut representing the centrelines on the overhead levers. As the string pairs crossed the nut obliquely there were one or two places where the hole could go, avoiding the strings, the sticker resting on the damper stool and its head under the centreline of the damper lever. These locations were marked with an awl and then drilled by eye through the nut and pinblock. One mistake was made, because of a broken drill bit a new hole had to be made next to a planned one. The instrument was tuned roughly to pitch and the damper stickers were fitted, sanded and smoothed as necessary and trimmed so that there was a small 0.5 -1 mm free motion before the sticker engaged the lever. This was done so that when playing a note, the hammer was the first to get the impetus of the stroke. Where cloth dampers interfered with a neighbouring string, they were trimmed back a little.

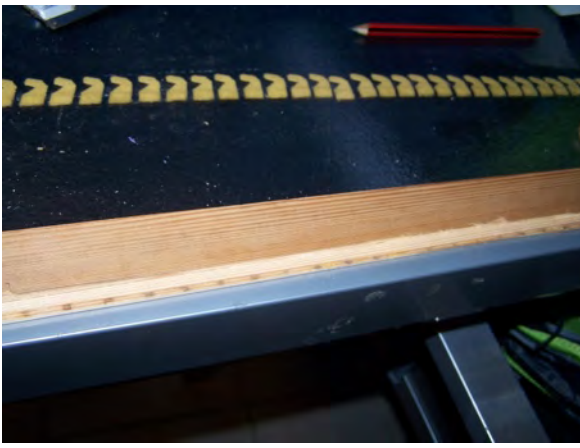
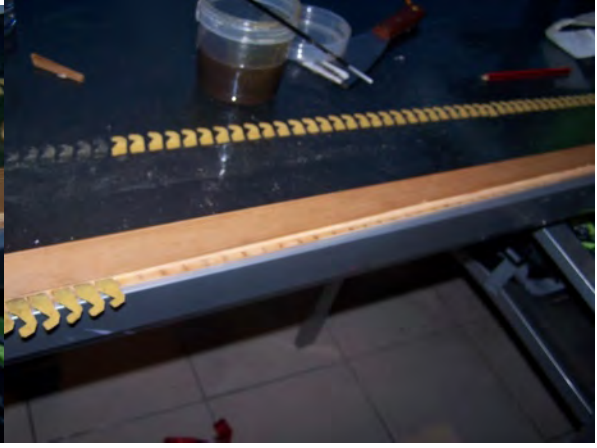
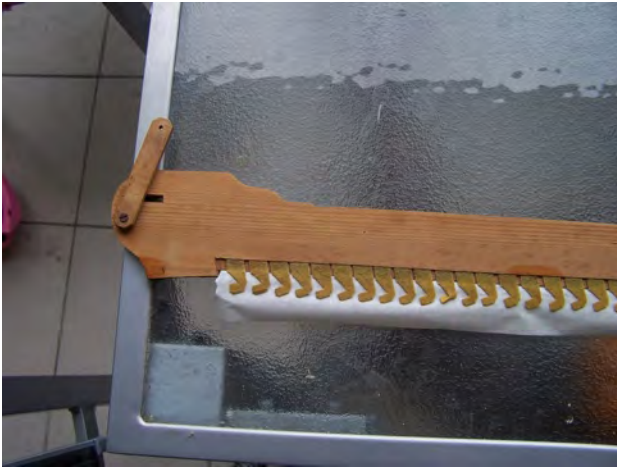
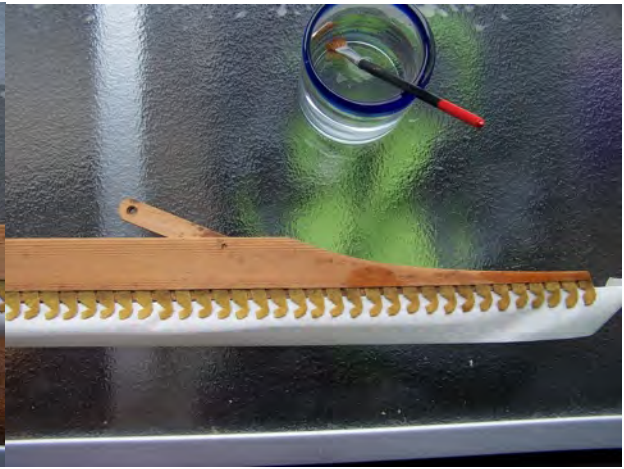
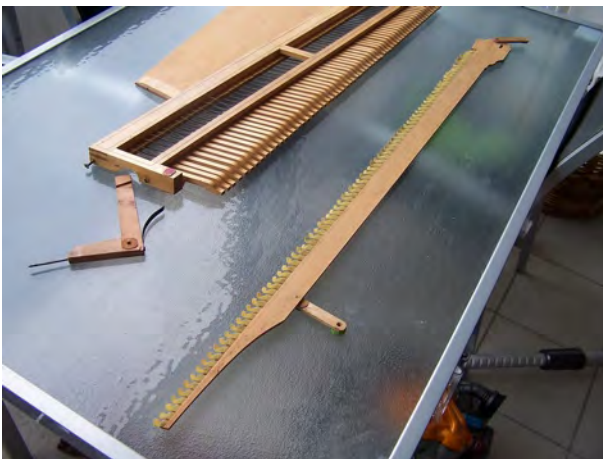
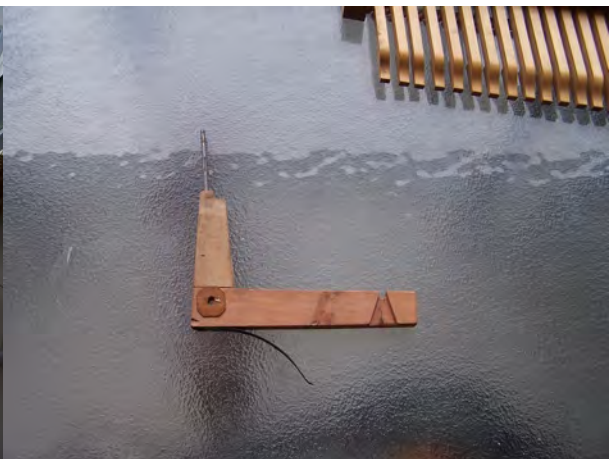
As the string positions and strike points had been altered, the position of the moderator tabs would need to be altered.

These were unglued by wetting them, and kept in order. The strike line was taken from the hammer head rear edges with the hammers at rest in the action and the existing batten front edge and top rabbet adjusted so that the moderator tabs would be engaged equally throughout the compass. The moderator tabs were then reglued and the moderator batten leather rubbing strips replaced and the moderator remounted.
