## Restoration of an Andrew Reuss square piano with 'Grand Viennese' action

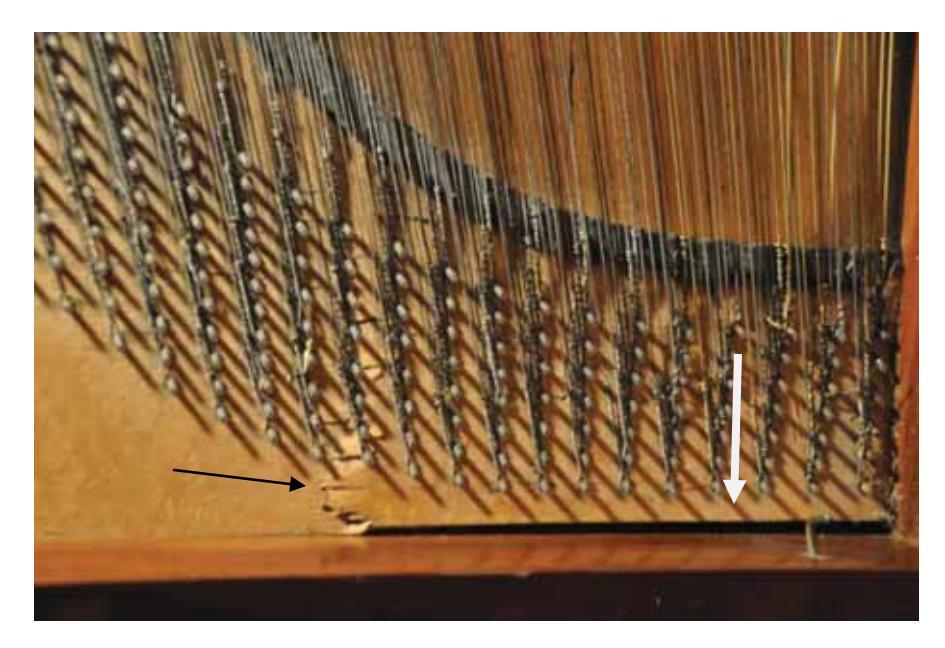
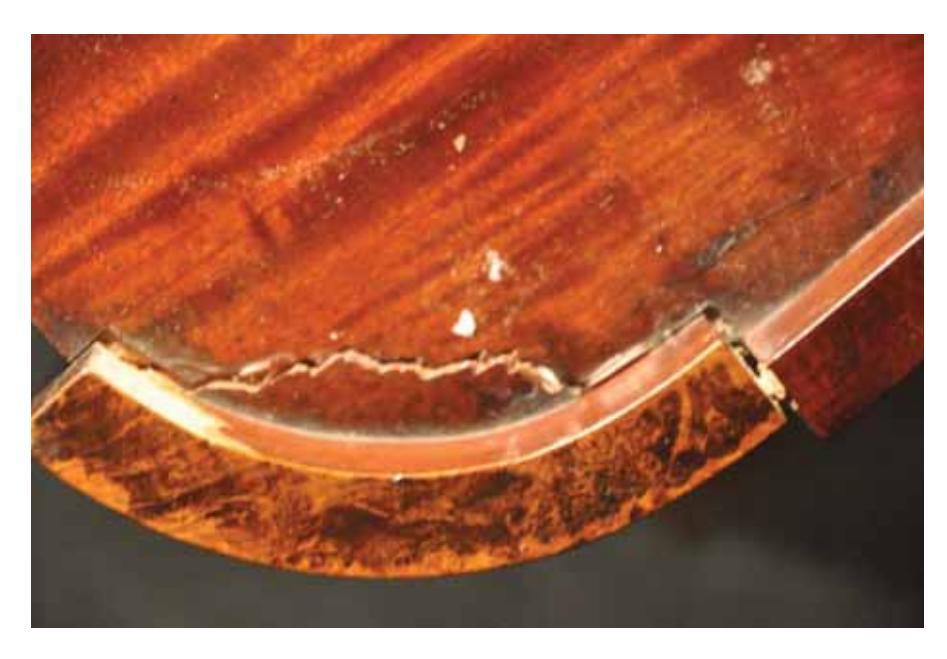
The piano arrived in a state of low tension, most notes did not play at all or were well away from pitch, many strings broken, and a sense that it had lain undisturbed except for moving for some number of years. An examination showed that the hitch pin block in the far upper right, which provides support for the bass section, had broken loose from the bottom and case walls and had partially torn the birdseye veneer. A few dampers were missing or dislocated, and the upper two hammers were missing from the key levers. In addition to the structural failure at the upper right, both corners of the case showed cracks and dislocations, and the left front cheek had lifted from the bottom boards. Given this serious mechanical failure, tension could not be possible on the instrument as found, and all these points would need to be addressed.

#### Right corner structural failure

The hitch pin block failed at the joint where additional wood was originally added to complete the block. This gives no real support other than the glue to this area. The introduction of a metal string plate here solved many concerns when introduced a few years after this piano was made. Evaluating the failure, we found the wood to be intact apart from the torn veneer, and the structure simply needing cleaning and gluing back into place. The area was flushed with boiling water to clean it, then warmed thoroughly with heat lamps. Clamping assist blocks of oak were prepared at a thickness to allow them to fit between the hitch pins and glue was injected into the disturbed areas with a large hypodermic syringe and needle, and the assembly clamped up.

Since it failed once, it will fail again, and rather than intrusively replacing out the entire hitchpin block with engineered wood, it was decided to return the current material to service, but to reinforce the block with stainless anchoring screws. These are 4 inches long and 3/16 in diameter, more than sufficient to keep the 2.5 inch thick block held in place. The veneer was cut away in 5/16 plugs with sharpened thin brass tubing such that it could be returned, the hole below drilled for shaft and then narrower for threads, and the screws put in under controlled torque to a point of being set well but not under excessive torque. The veneer was then returned. With the finish restored the cuts disappear.

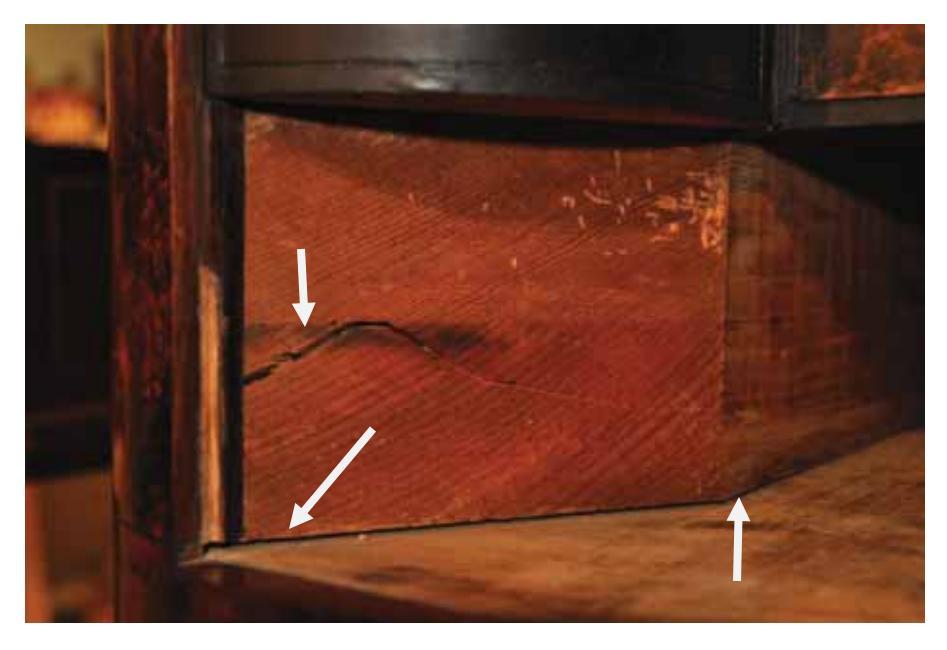
Left cheek failure, action removed.

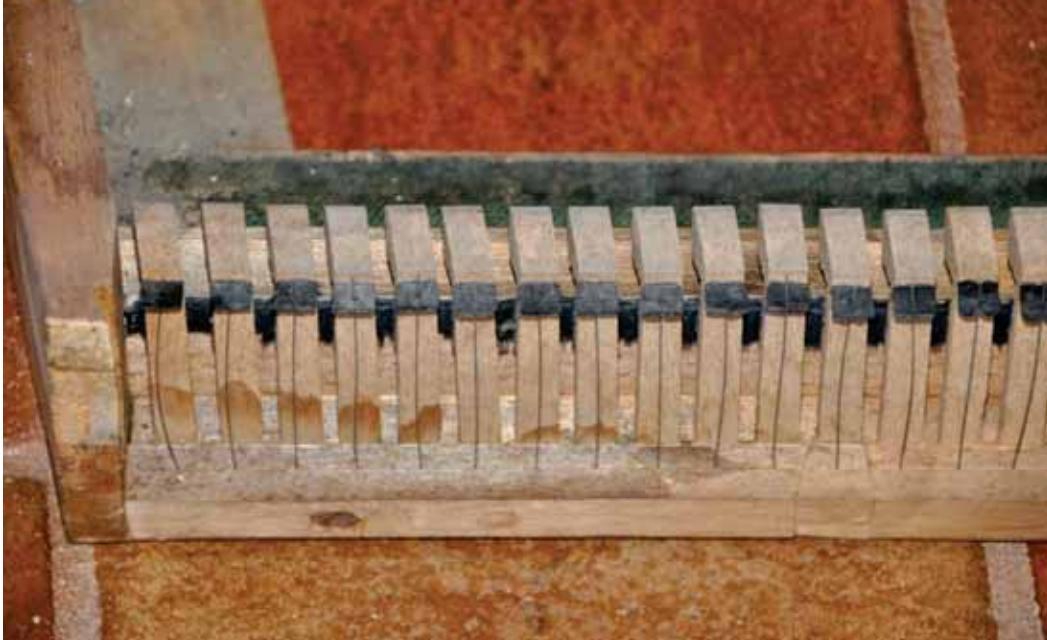
Escapement pawls from rear

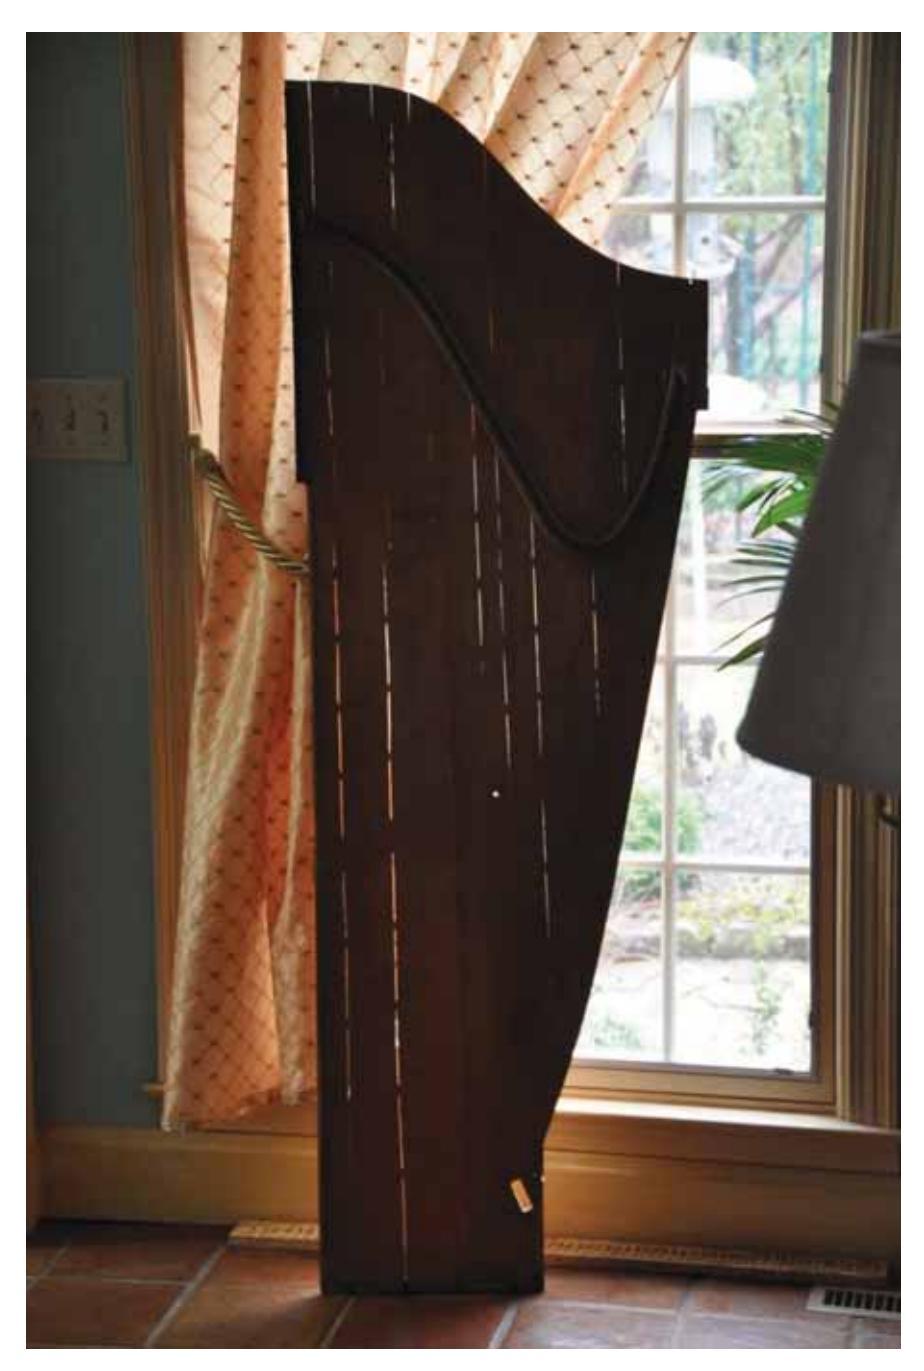
The failure of the wrestplank had put pressure on the soundboard, which is very thin at about 2.5 mm thickness, and the soundboard was cracked in perhaps two dozen places, some worse than others. Very little material had been lost however, and these sort of cracks generally respond well to careful expansion with wetting and gluing, with a thin linen backing for support on the bottom. Wider cracks could be shimmed. The soundboard was in a spruce, the species not identified, but microscopically similar to spruce species in North America.

On removal, the sound board was evaluated for repair, and it was decided that the bridge and ribs could remain in place in order to effect the corrections. A photo of the soundboard backlit is seen below:

Repairing the soundboard involved identifying which cracks had seen poor repair in the past and removing loose or non functioning shims, and which cracks were superficial and could be re-glued. Splits often respond well to wetting and clamping after gluing together, with a linen backing for support. A high grade artist linen is used for this support, about 0.25 mm thick. Once saturated in glue, the linen strip can add much reinforcement without affecting the sound quality. It is not a good fix where vertical stress will be applied though, and soundboards that have failed due to down bearing might be

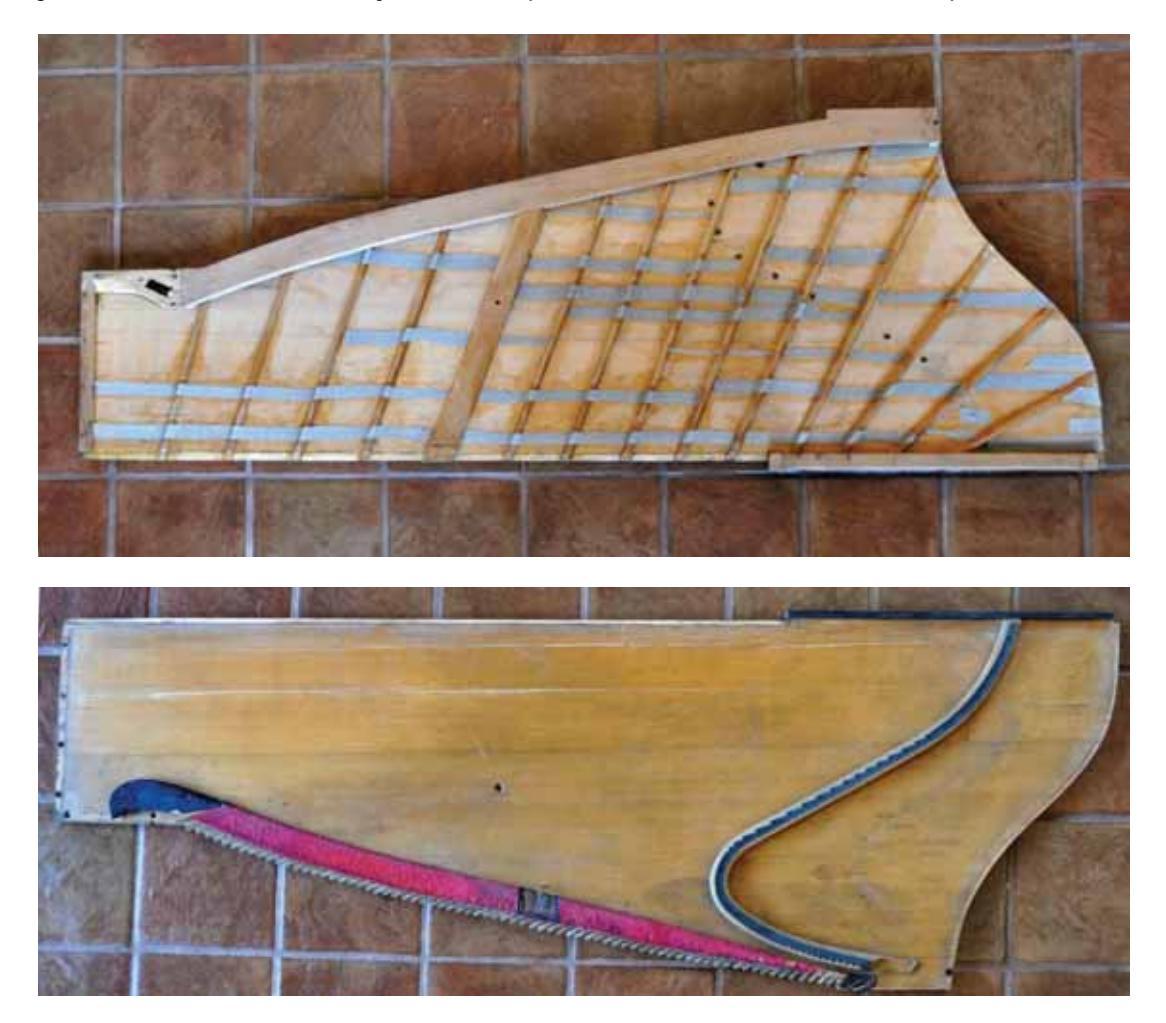
The repaired soundboard with moderator stop set in place to show location.

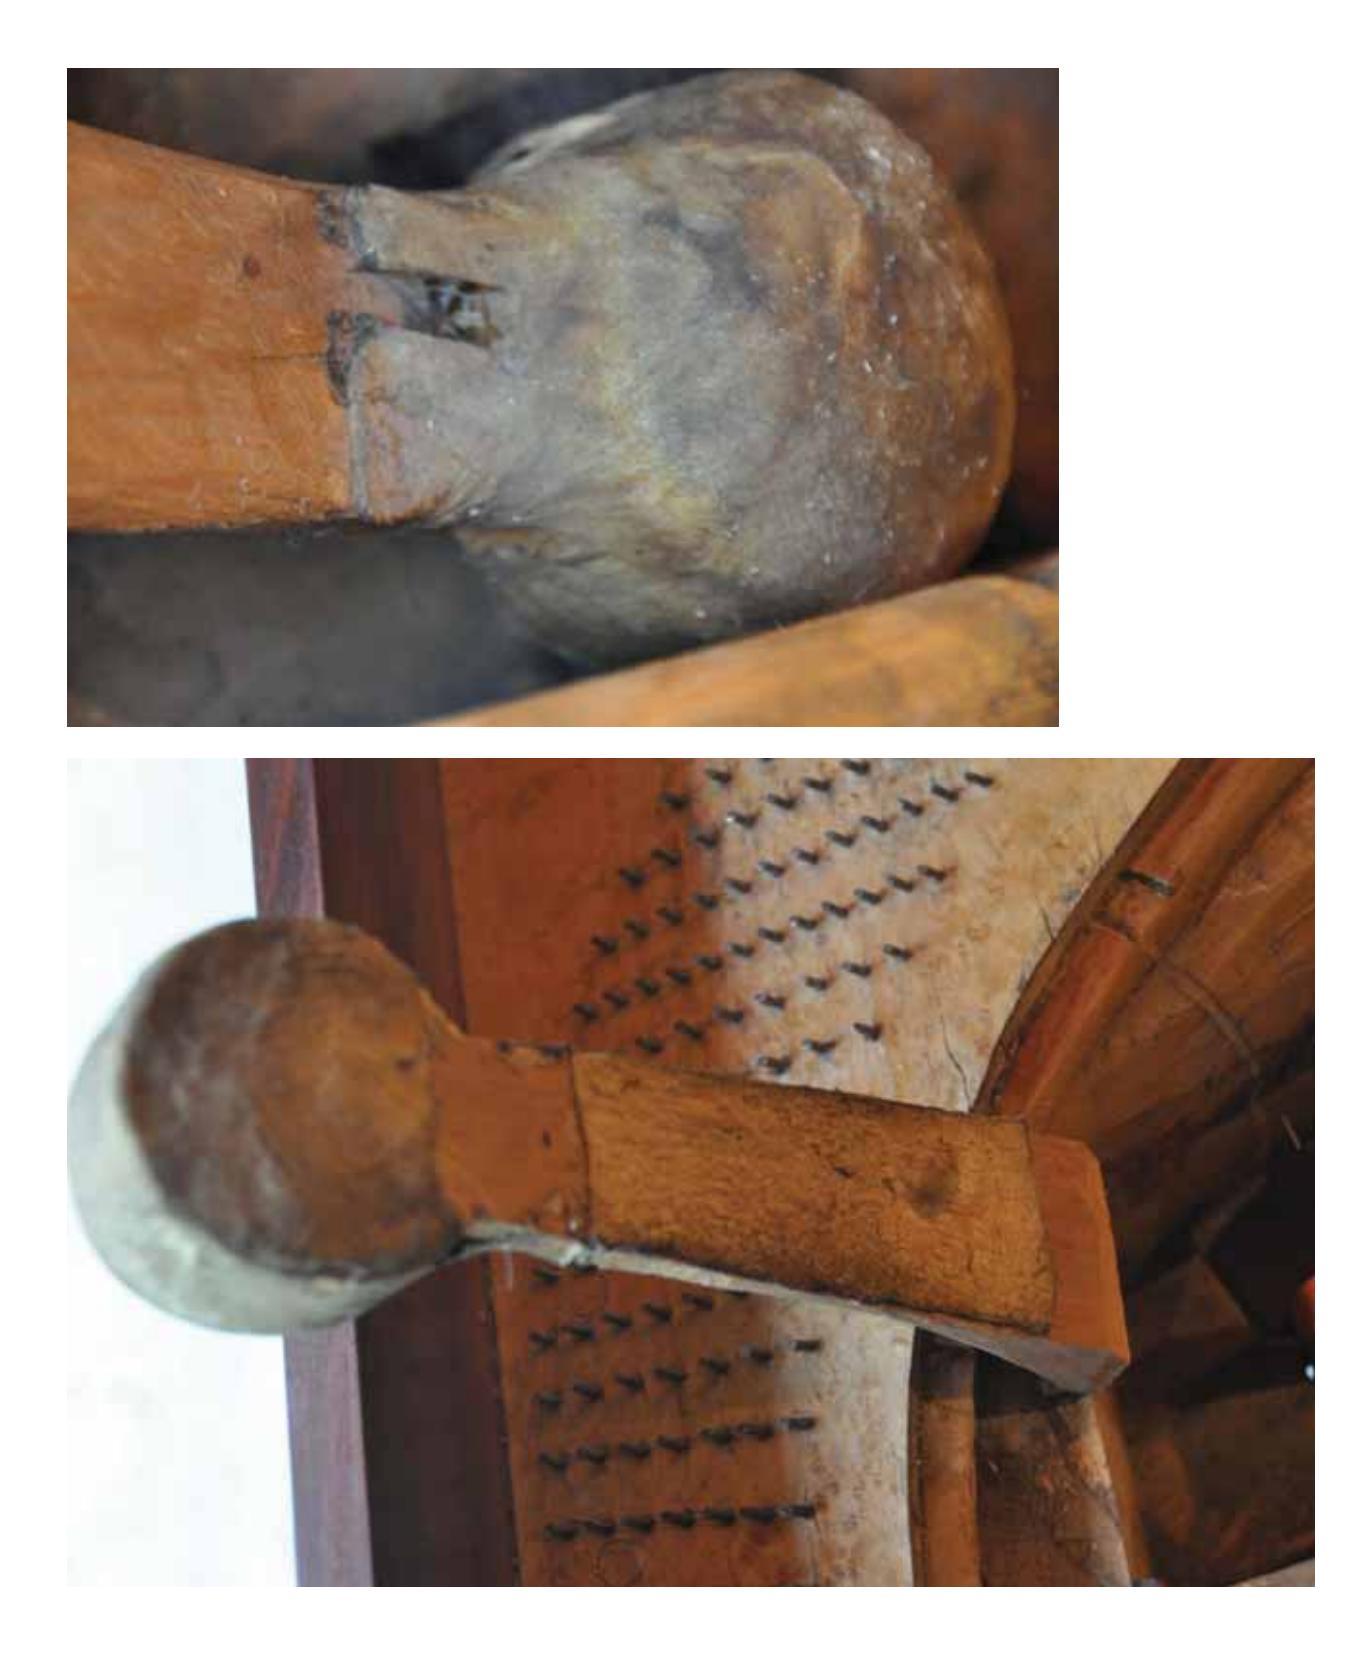
The sticker for lifting the beater was in place, its top cover worn through, and missing from the side was the arm to lift the spring arm for the bell. This part was easy to make as suggested by witness lines on

the sticker, and functions well once in place. The leather hinge for the wood that holds the spring arm was returned as found to service.

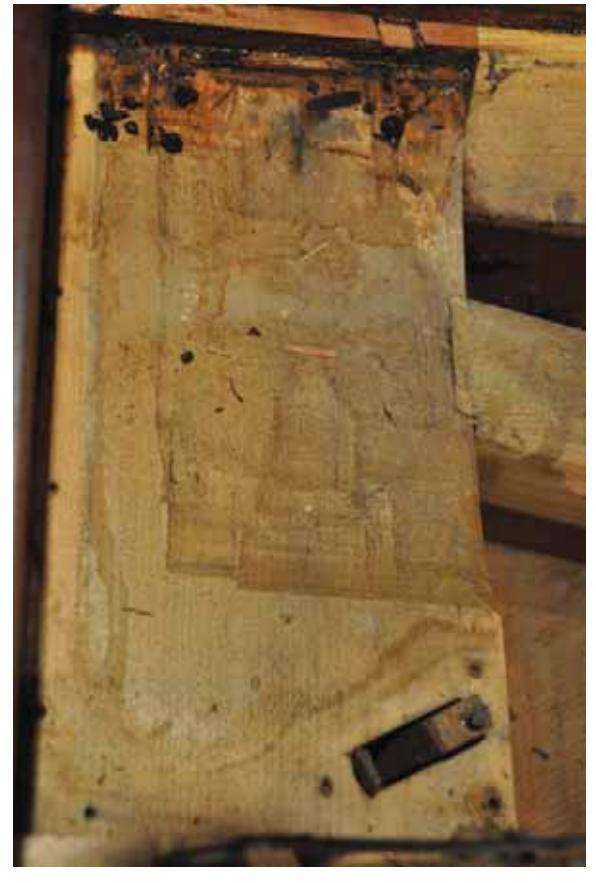
Left hand side

Structurally the case was good inside, and uses a beam down the center and dadoed into a belly rail, all of which is clued to the case bottom boards, to withstand the effects of tension. These joints were checked and glue added where it had given way from twisting.

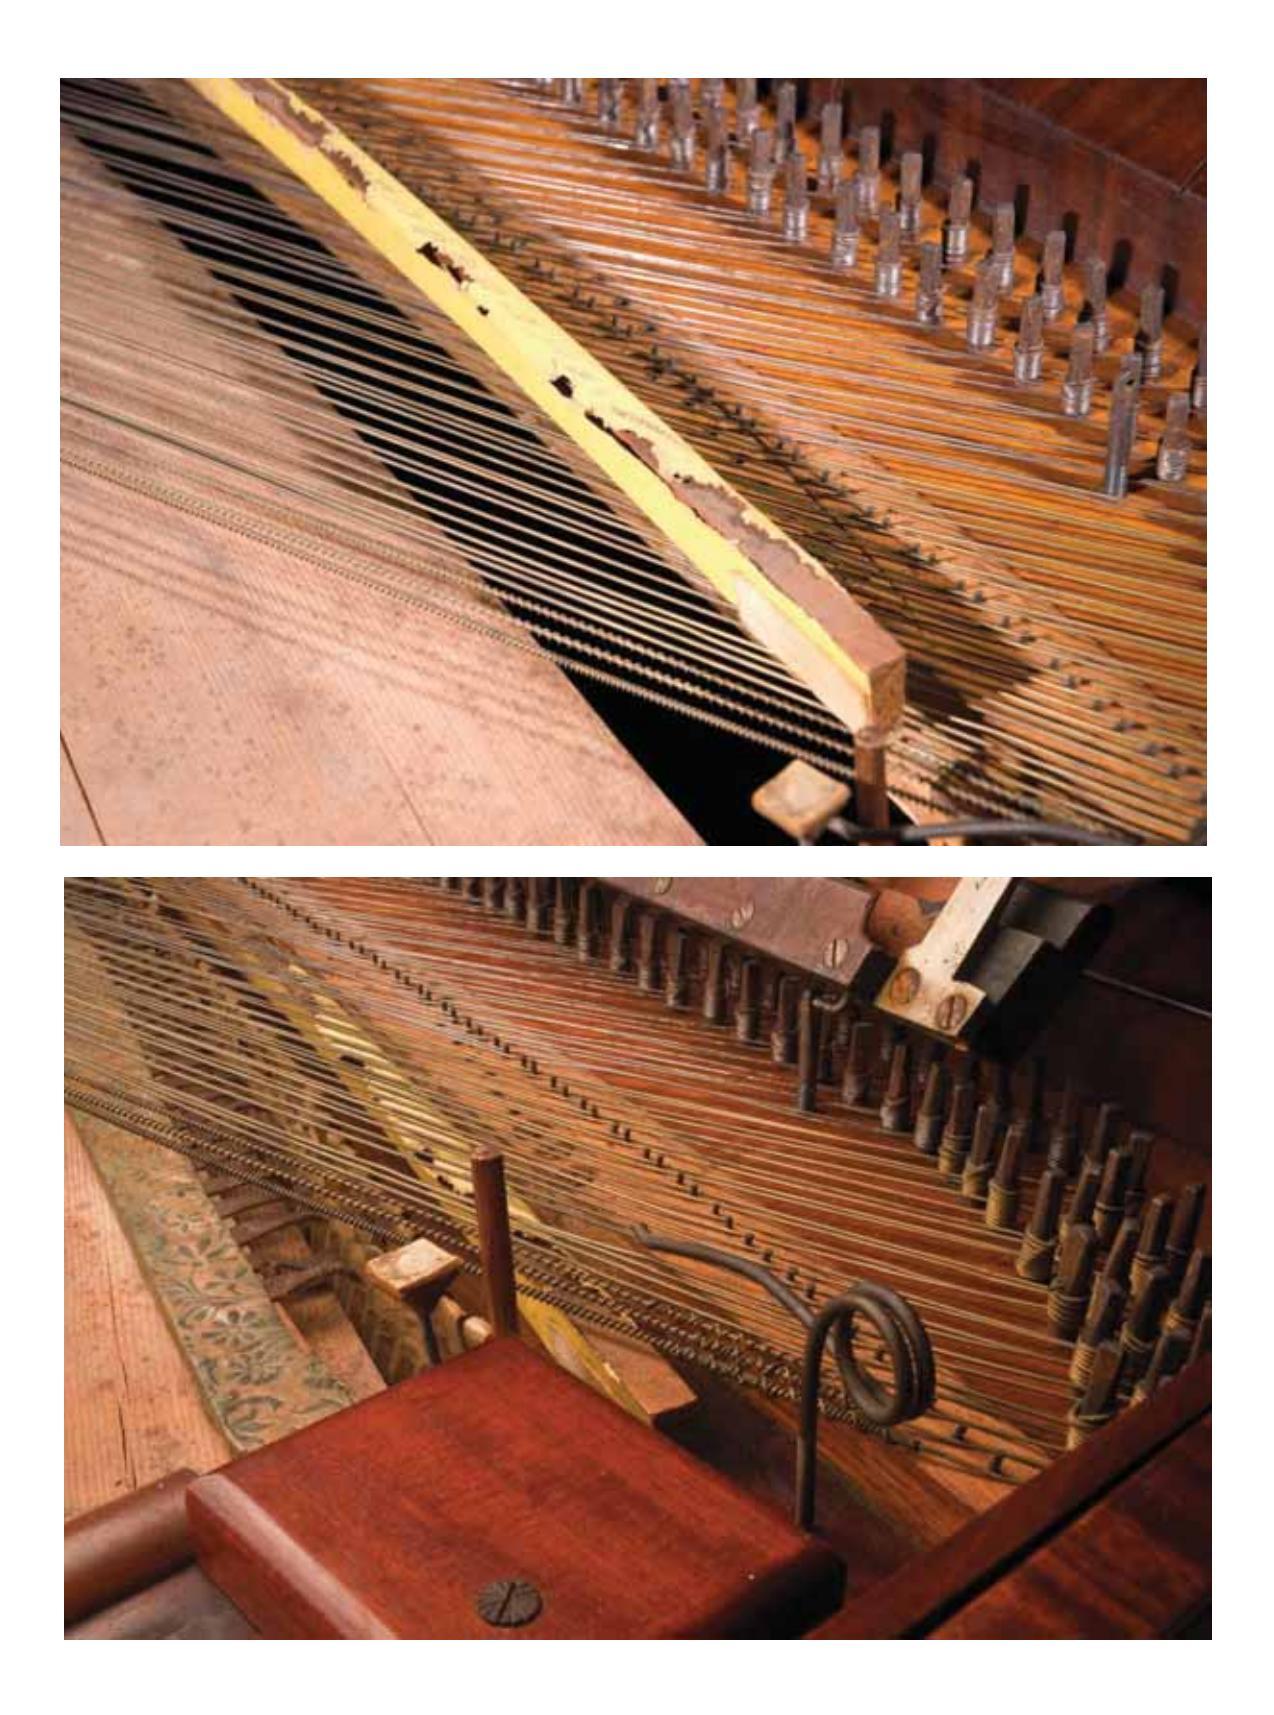
The Reuss bassoon stop bar installed.

The bassoon stop was missing from the piano and was reconstructed based on an example still present in the Joseph Newman piano at Colonial Williamsburg. This is a sawn and tapering curved bar, attaching to the back of the wrest plank by a pivot screw, with the other end tilted up by a sticker rod activated by the pedal. The total travel of the bassoon stop is about 1 cm. The paper loop is formed of a stiff stock (in this case we formed it of a heavy marbled paper) and the height adjusted along the length of the bar such that as the bar is raised the paper meets the strings at about the same point down the length.

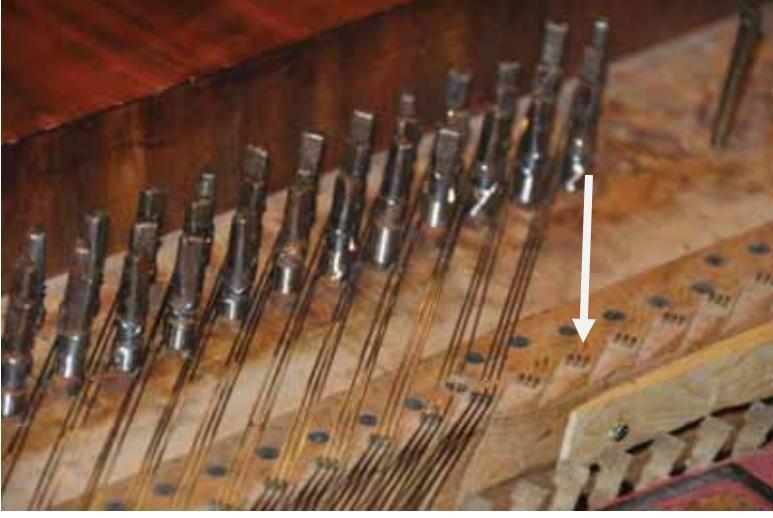
Bassoon pivot point.

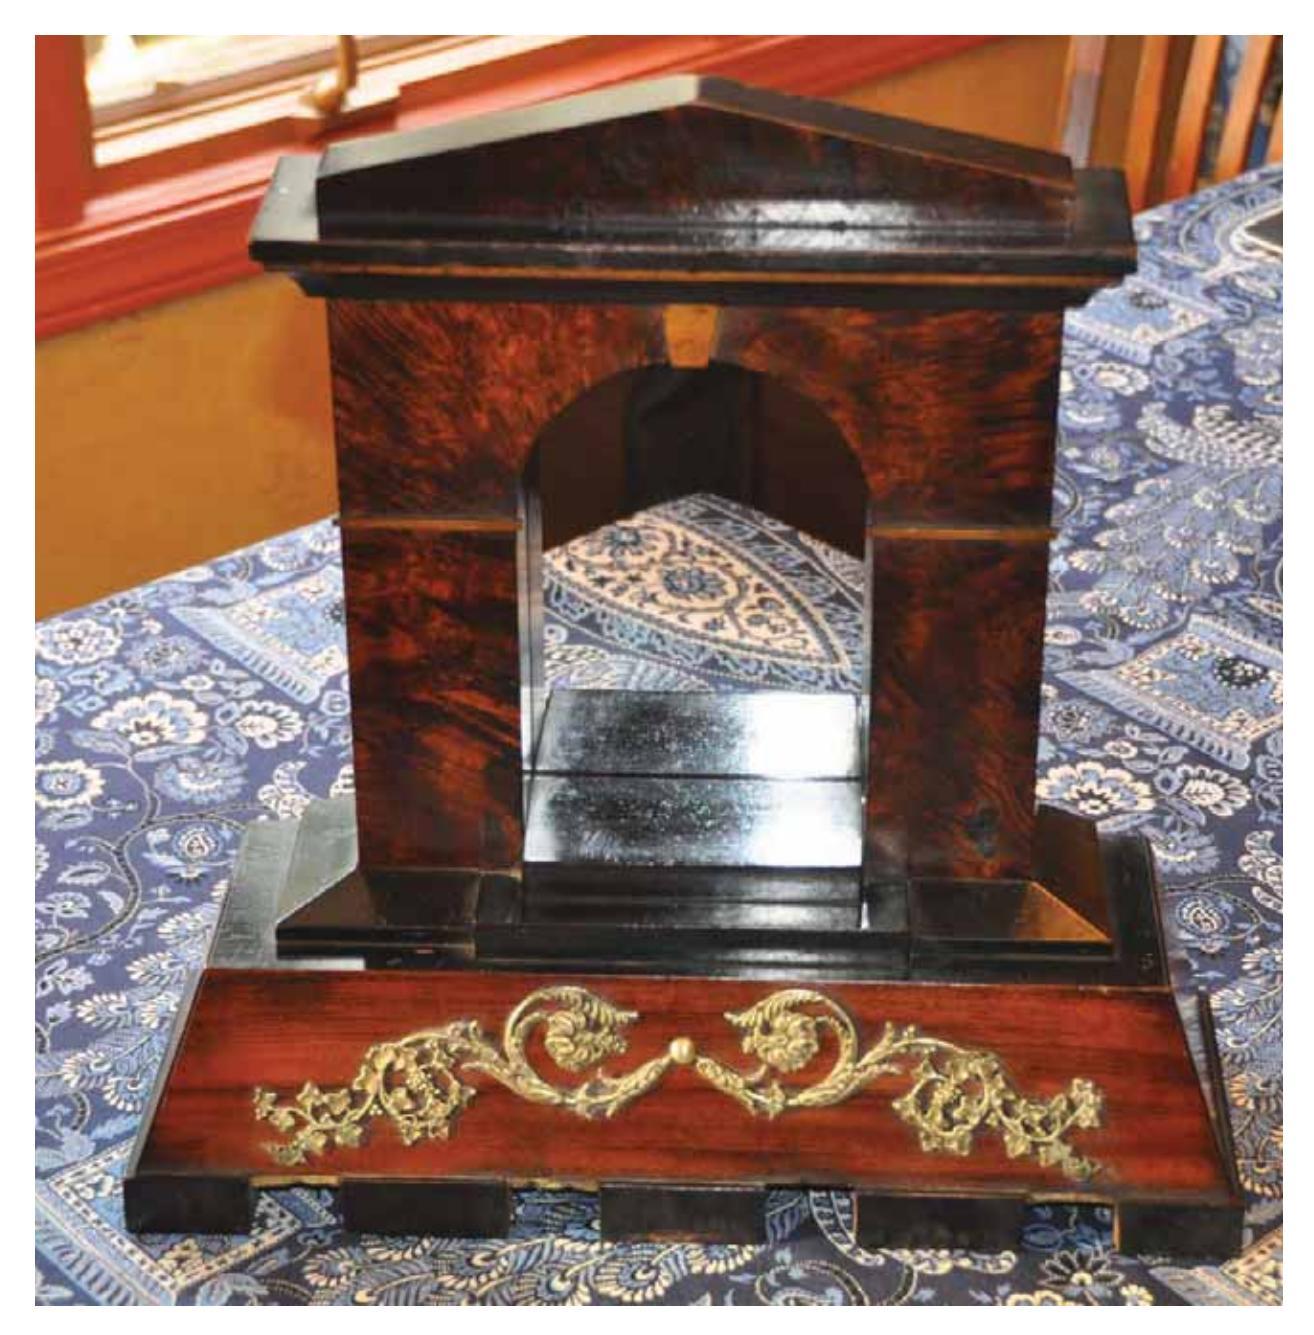
The stand was complete, but the mirror that was once in the pedal box was missing. All pedals and connecting rods accounted for.

As reconstructed with mirror replaced in middle.
