Restoration of a Broadwood square piano, 1793

Thomas Strange – Jan 2010

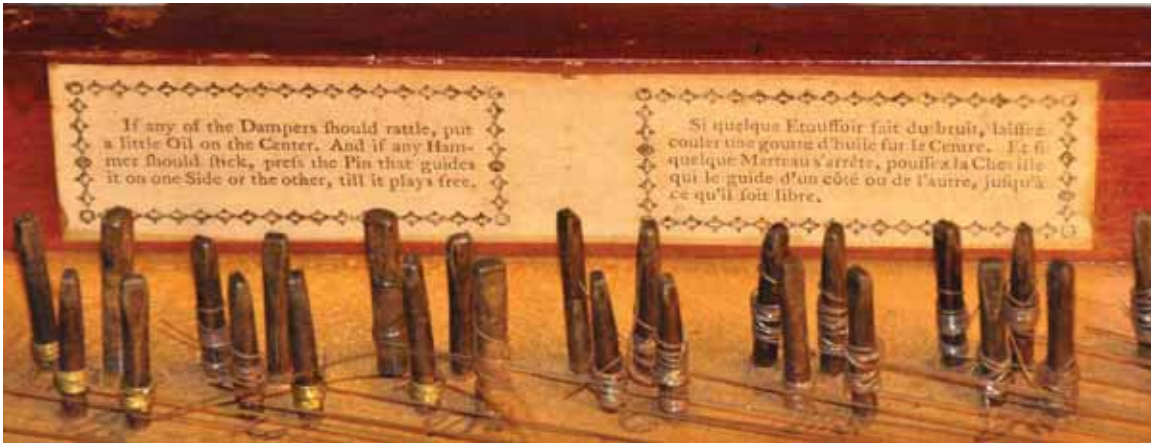
All of the iron strings were original, but the act of loosening them on the tuning pins left them in a jumble around each pin shaft, many of the brass were broken, as well as 10 of the 26 over spun strings. To make the piano play, strings were moved about at random and looped to the wrong hitch pins, such that the lowest two octaves were either wrong or missing altogether. The top three octaves of iron were largely still there, but fragile due to the improper winding now on the tuning pin. At some point 7 oversize modern 1/4 inch pins designed for mid 19th century square pianos were used in place of pins that had probably become too loose. These were removed entirely and set aside.

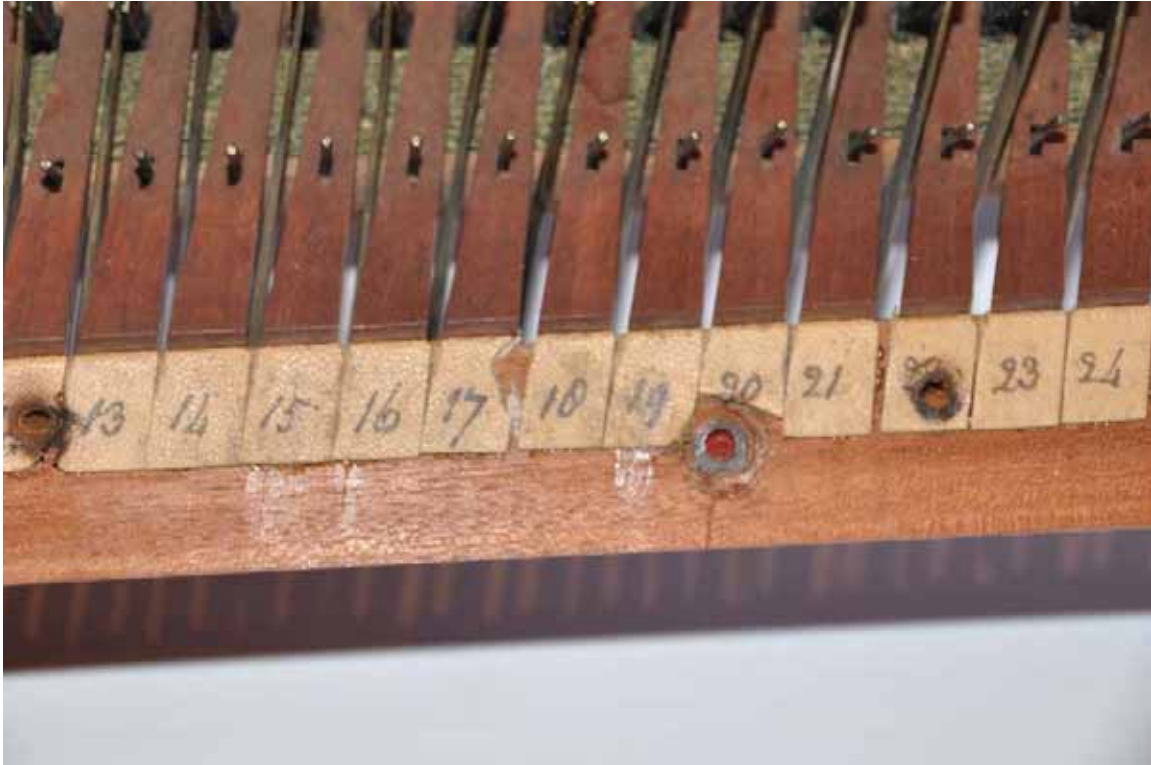
The hammer hinges beneath the hammer rail top are individually numbered as shown. These are of course all original to the instrument, and are in the hand of the keyboard maker, probably Mr. Hendenon.

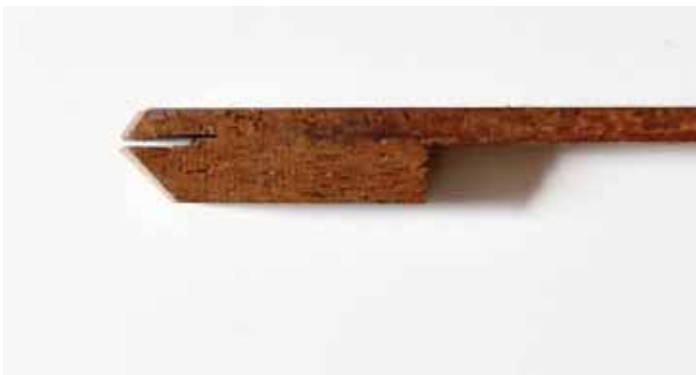
The lowest bass hammer (FF) was broken at the hinge. The end was soaked in very hot water to loosen the glue and the remaining leather slid out. New goat skin was shifted into place and glued, then the flap trimmed and glued to the hammer rail. The hinge should stand just proud of the edge of the hammer rail by about 0.5 mm to 1.0 mm but no more, or the hammer will have excessive play on actuating.

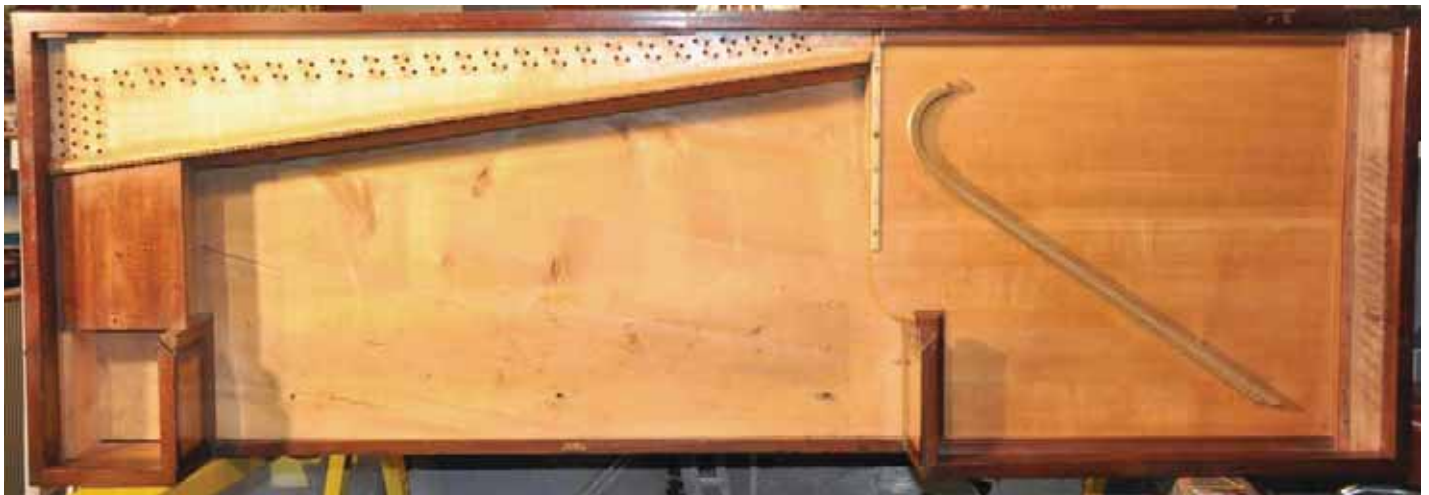
Gap to be repaired

The case is mostly intact with the left side showing some parting with the baseboard in the left rear corner. This was to be repaired as described.

The gap was washed out with hot water shot from a syringe until the water ran clear. Hot hide glue (Luthiers Mercantile Int. FHG #192 gram strength) was liberally injected and the case was clamped to close the gap, and excess glue wiped up. The clamped case was allowed to sit 48 hours, and while still under the clamp, three holes were drilled for 4 inch stainless steel screws, which were given a pilot hole into the case, a through hole of the baseboards, and counter sunk to clear the head. The screws were driven in under torque to 5 ft-lbs. The screw acts as a lateral anchor to keep the case from shifting and breaking the glue, but the glue does all of the bonding of case to bottom boards.

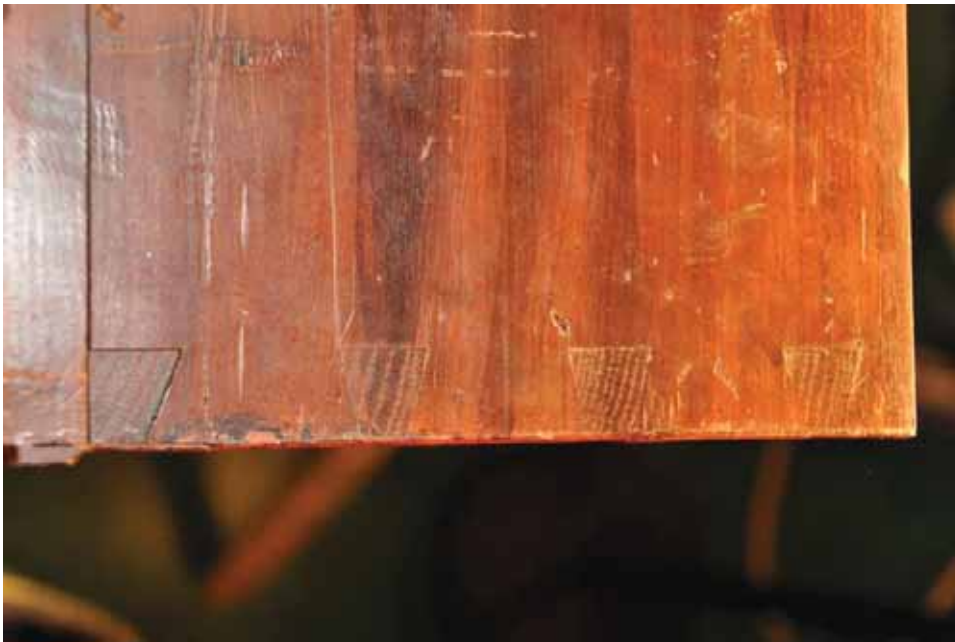
Dove tails at back of case

In general once properly re-glued and screwed the case will give no more difficulty. With through and blind dovetailing at all corners the case is magnificently strong and resistant to warpage. The Achilles heel is the connection to the base boards, which is a simple flat glue joint to the rather thick case wall (~1.5 inches at base). The baseboards are two runs of 1.5 inch pine, one run lengthwise parallel with the case, and the top run parallel with the strings.

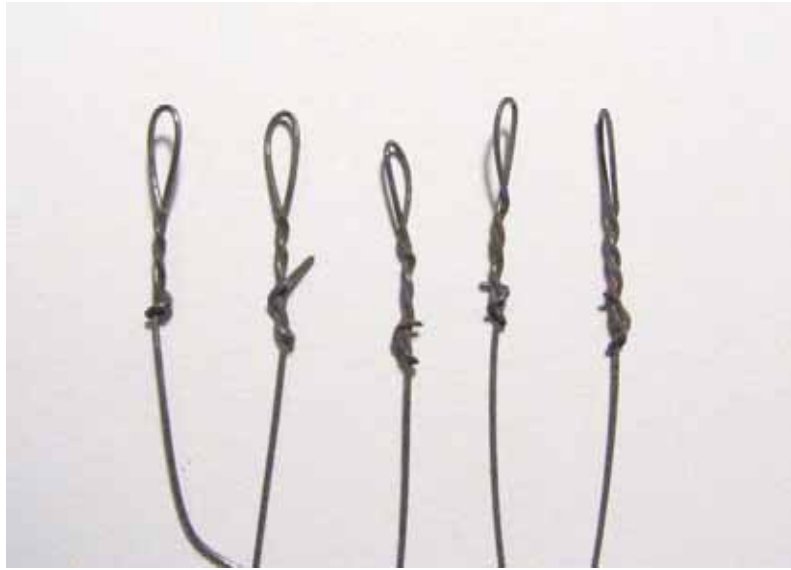
This instrument had the original hitches made in a very satisfactory alternative way. The wire is looped as before and a few (3-5) spirals made, when the loose bit is doubled back

Some original hitch loops from Broadwood square.
