# Restoration report

## South German or Austrian Tafelklavier c. 1830-40

Andrew Nolan, Broadbeach, Queensland. copyright 2011

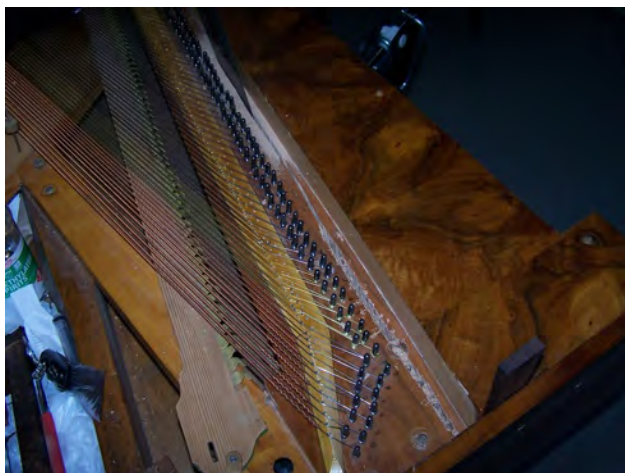
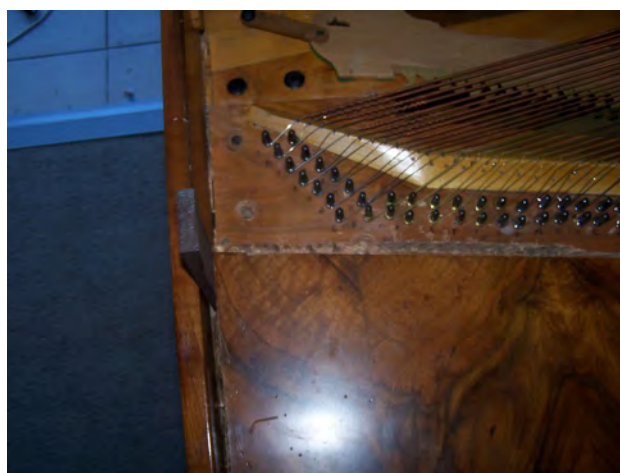
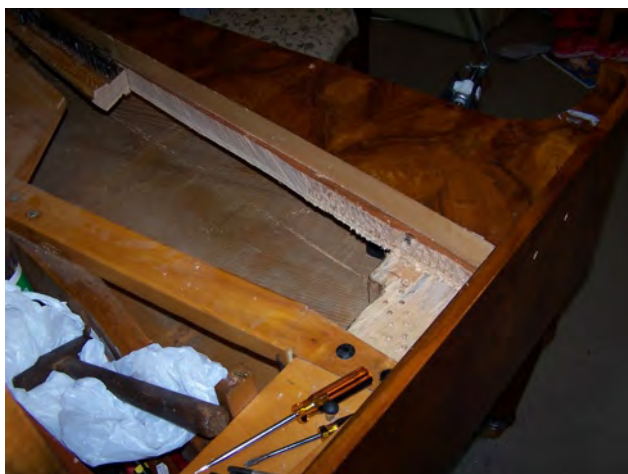
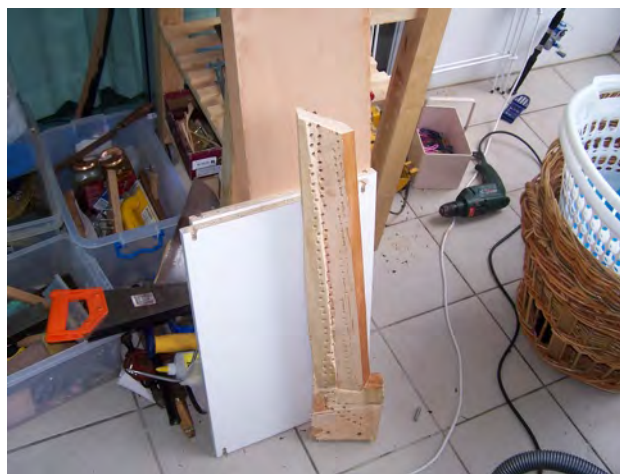
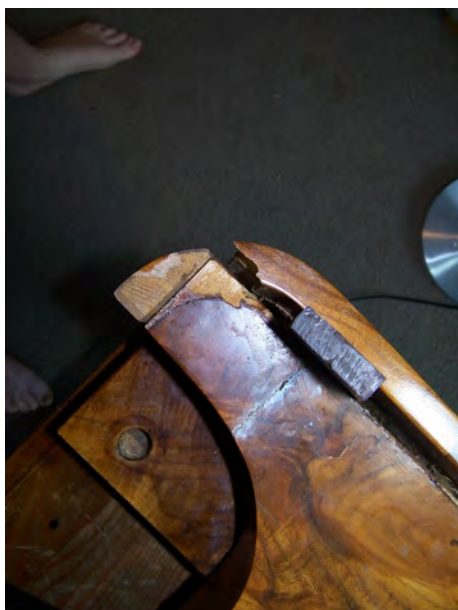
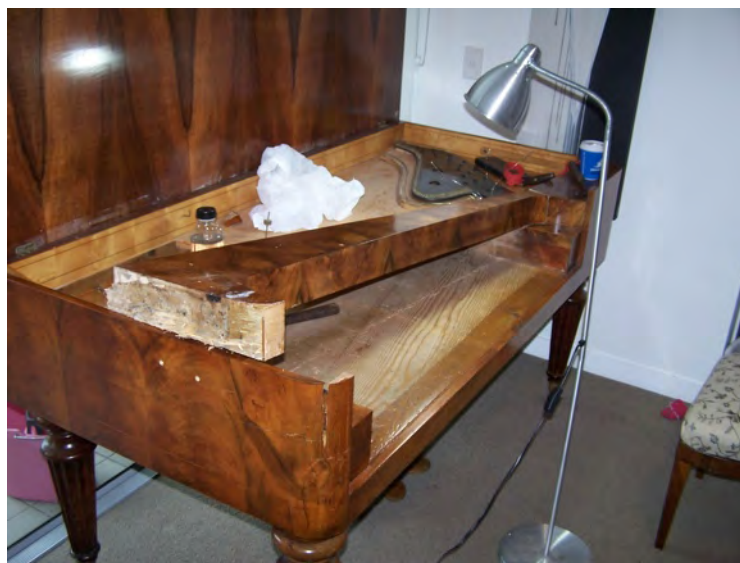
The joint surfaces were thoroughly cleaned of PVA glue residue. In many areas the previous workers had not bothered to remove the previous hide glue under the PVA, this made the job somewhat easier. It was surprising to think that instrument had actually been

fairly stable regarding tuning, even when glued with PVA, I attribute this to the large gluing surfaces involved and the mechanical lock-in nature of the joints.

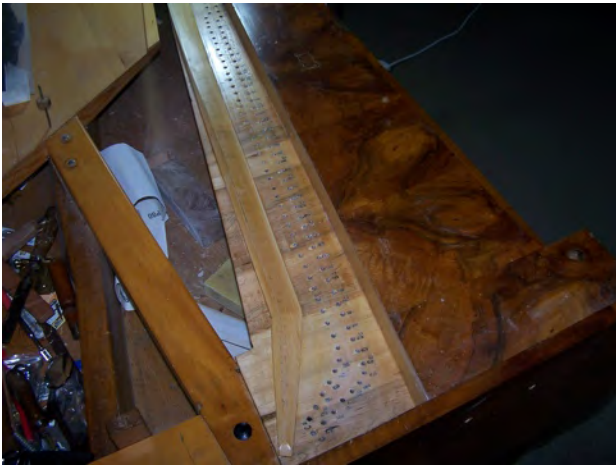
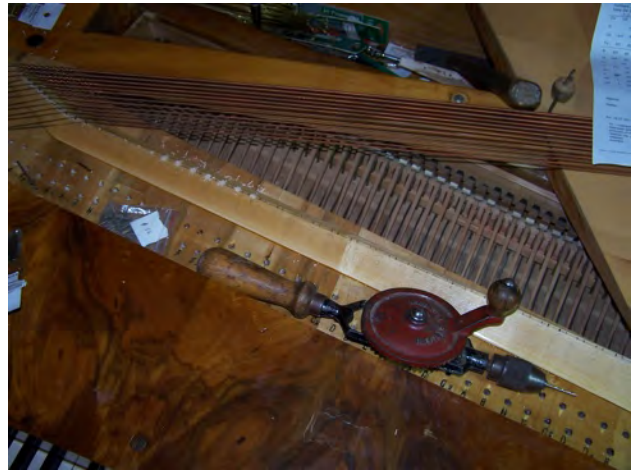
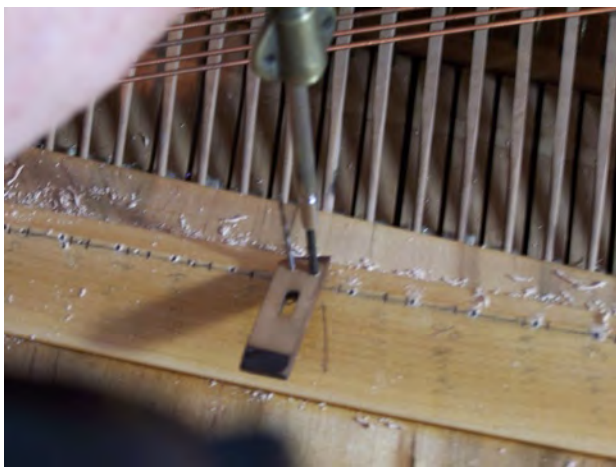
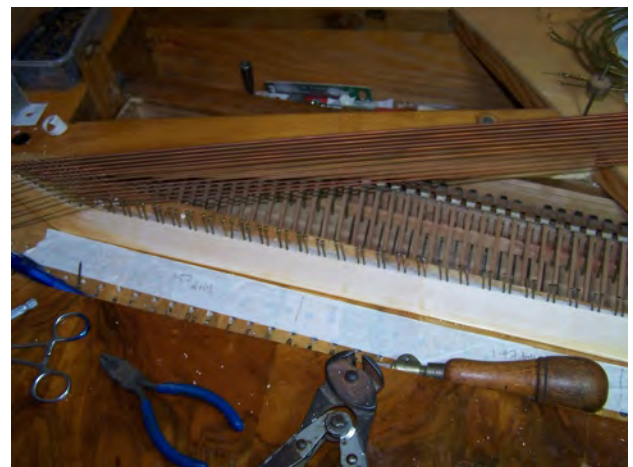
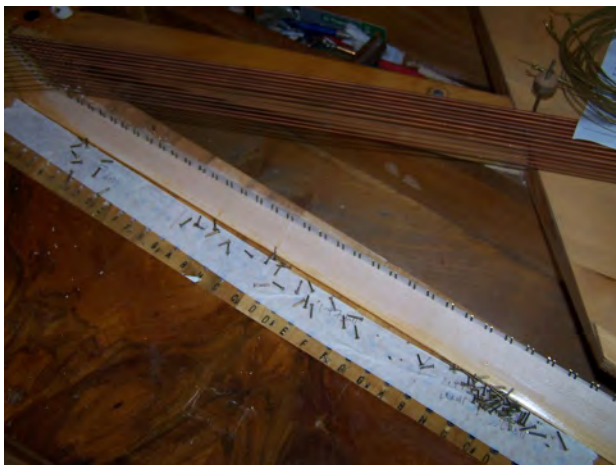
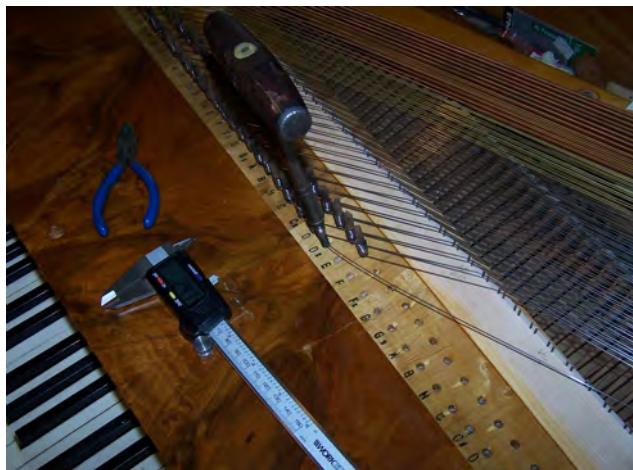
After the pinblock /yoke assembly was glued and the bolts and screws tightened, the case side/ left front corner was attended to. The veneer on the bass side had been damaged by the previous restorer and the underlying case side pine has been split in multiple places. Using hide glue and gently heat and water to remelt glue it was possible to push everything back in position to provide a decent cosmetic result. The area will then be treated with lacquer sticks to disguise missing veneer chips and tinted nitrocellulose spray used to refinish it.

The pinblock/nut/ yoke area was finished with tinted shellac and the nut drilled and pinned using brass pins starting at 2mm diameter in the bass and finishing at 1.4mm in the treble. The tops were cut to length using a wooden stop and then filed to equal length. The instrument was then strung according to the schedule worked out previously and brought to pitch.
