## Restoration of an Andrew Reuss square piano with 'Grand Viennese' action

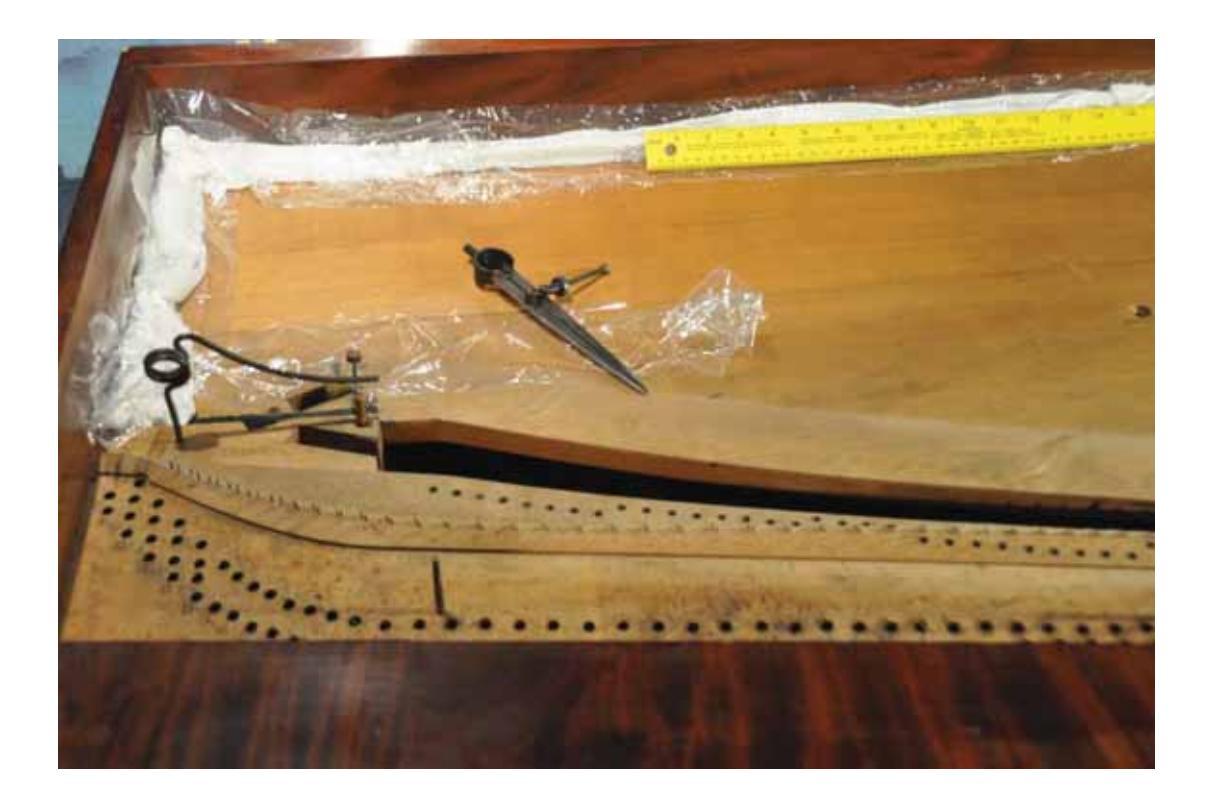
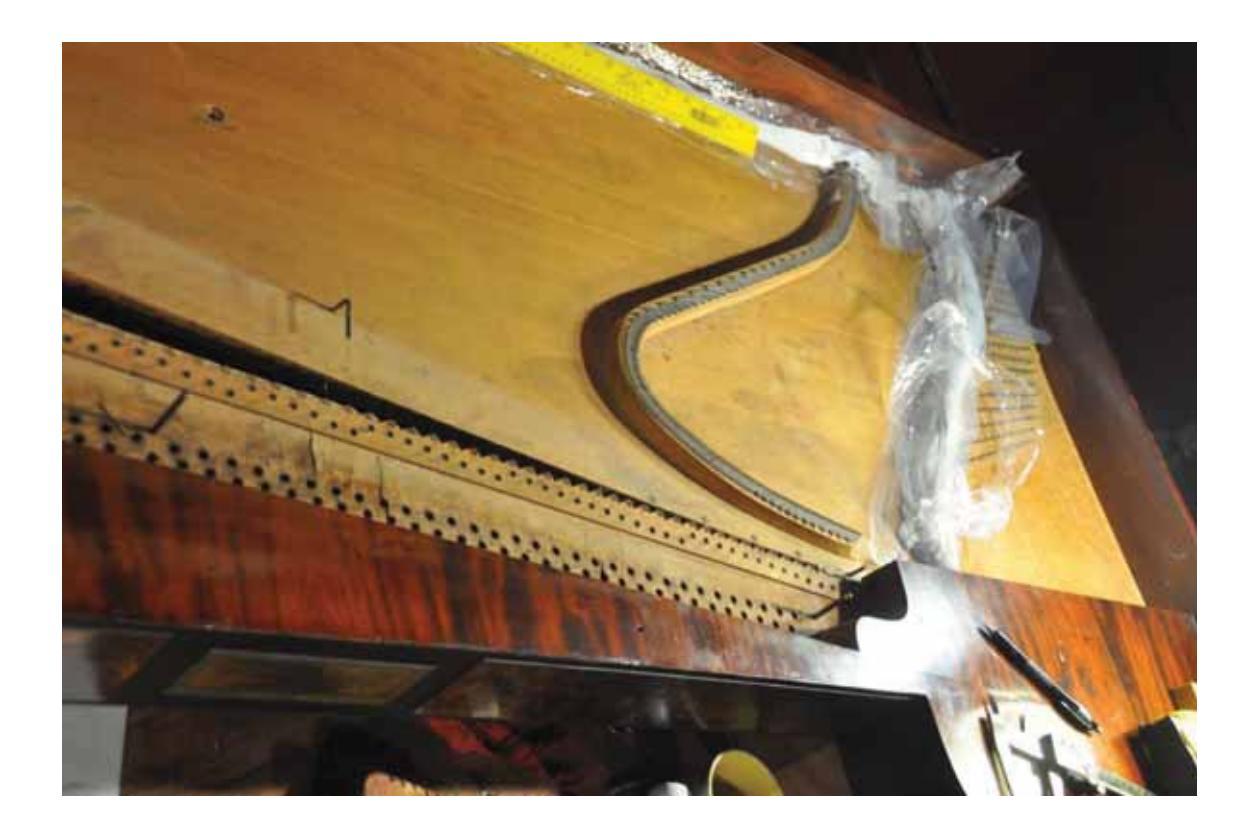
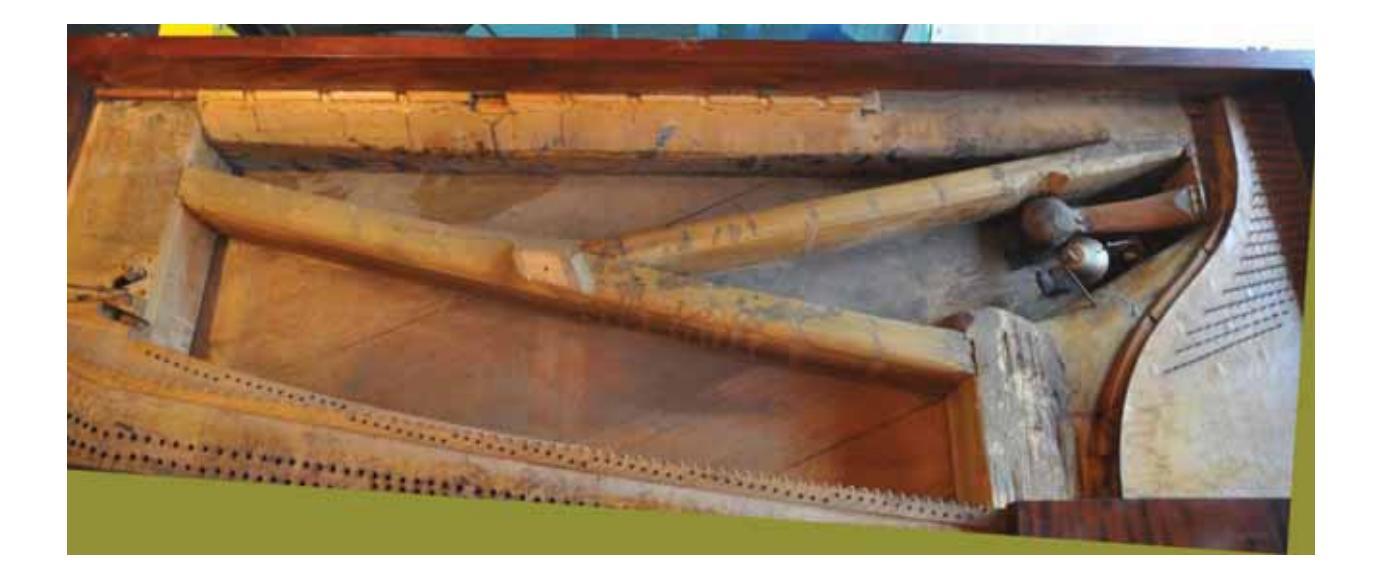
On the Viennese style piano, the soundboard lies across the width of the instrument, and is secured by screws and glue on the left hand side, and a molding strip and glue along the left rear seam, but with a discontinuity near the right rear. The right hand 'S' curve of the soundboard is covered in a screwed- in molding and glued as well, but it is free along the entire front edge, which is removed with the sound board and secured with screws at left and right front. The 'S' curve is covered in parchment/black cloth where visible.

Given this arrangement, wet rags were packed along the glued seams and covered in plastic to reduce evaporation. In 48 hours of occasional tending to keep moisture in place, the board had released to the point where the seams could be heated with heat lamps and the board extracted intact.

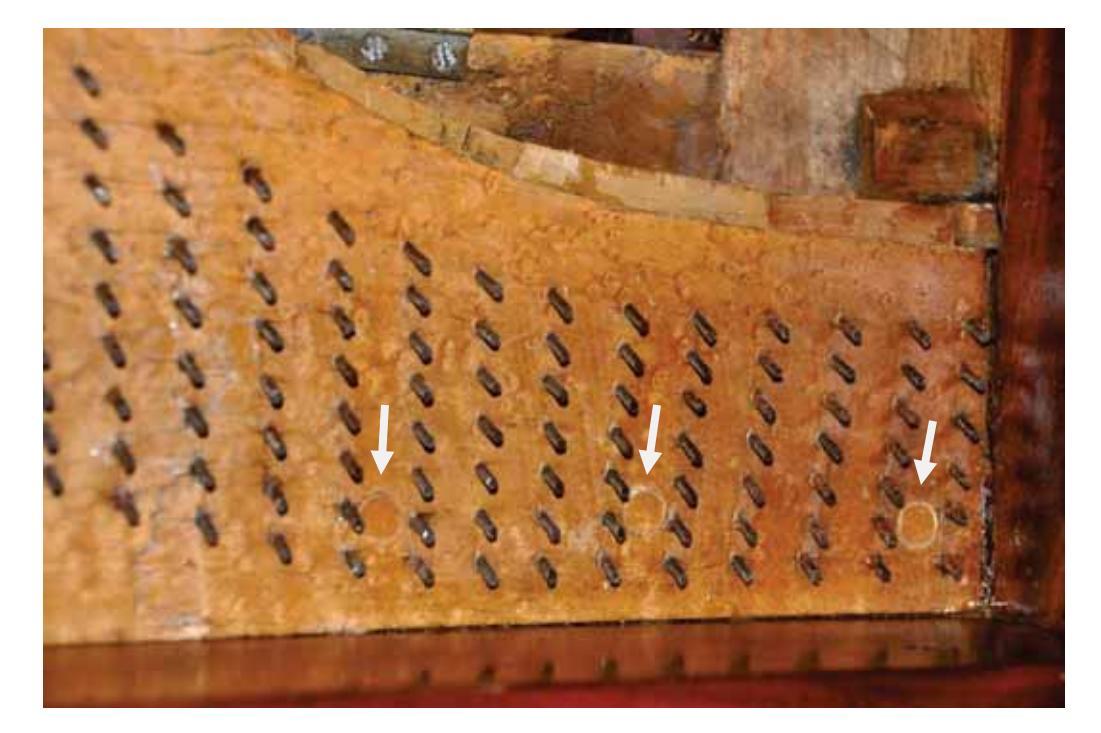
The hitch pin block failed at the joint where additional wood was originally added to complete the block. This gives no real support other than the glue to this area. The introduction of a metal string plate here solved many concerns when introduced a few years after this piano was made. Evaluating the failure, we found the wood to be intact apart from the torn veneer, and the structure simply needing cleaning and gluing back into place. The area was flushed with boiling water to clean it, then warmed thoroughly with heat lamps. Clamping assist blocks of oak were prepared at a thickness to allow them to fit between the hitch pins and glue was injected into the disturbed areas with a large hypodermic syringe and needle, and the assembly clamped up.

Since it failed once, it will fail again, and rather than intrusively replacing out the entire hitchpin block with engineered wood, it was decided to return the current material to service, but to reinforce the block with stainless anchoring screws. These are 4 inches long and 3/16 in diameter, more than sufficient to keep the 2.5 inch thick block held in place. The veneer was cut away in 5/16 plugs with sharpened thin brass tubing such that it could be returned, the hole below drilled for shaft and then narrower for threads, and the screws put in under controlled torque to a point of being set well but not under excessive torque. The veneer was then returned. With the finish restored the cuts disappear.

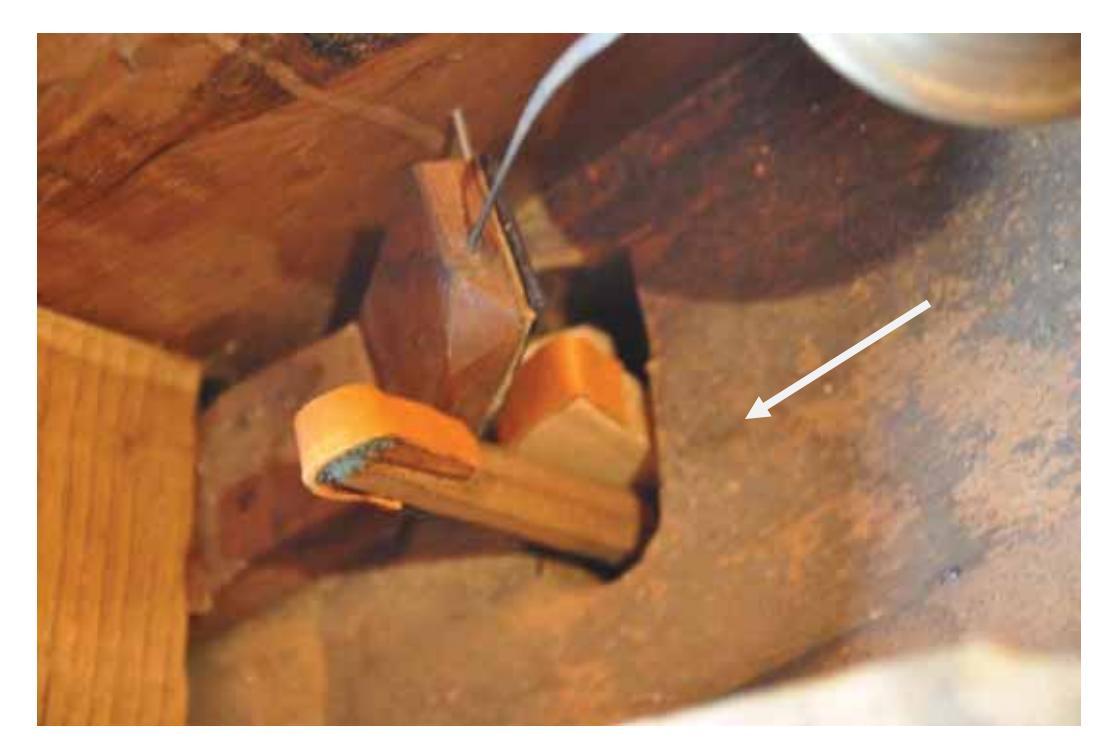
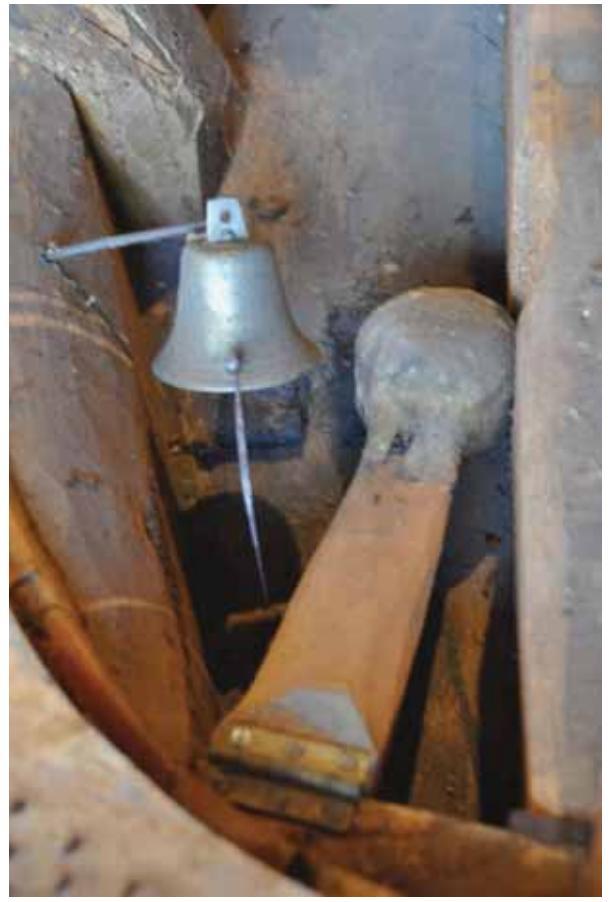
The sticker for lifting the beater was in place, its top cover worn through, and missing from the side was the arm to lift the spring arm for the bell. This part was easy to make as suggested by witness lines on

the sticker, and functions well once in place. The leather hinge for the wood that holds the spring arm was returned as found to service.

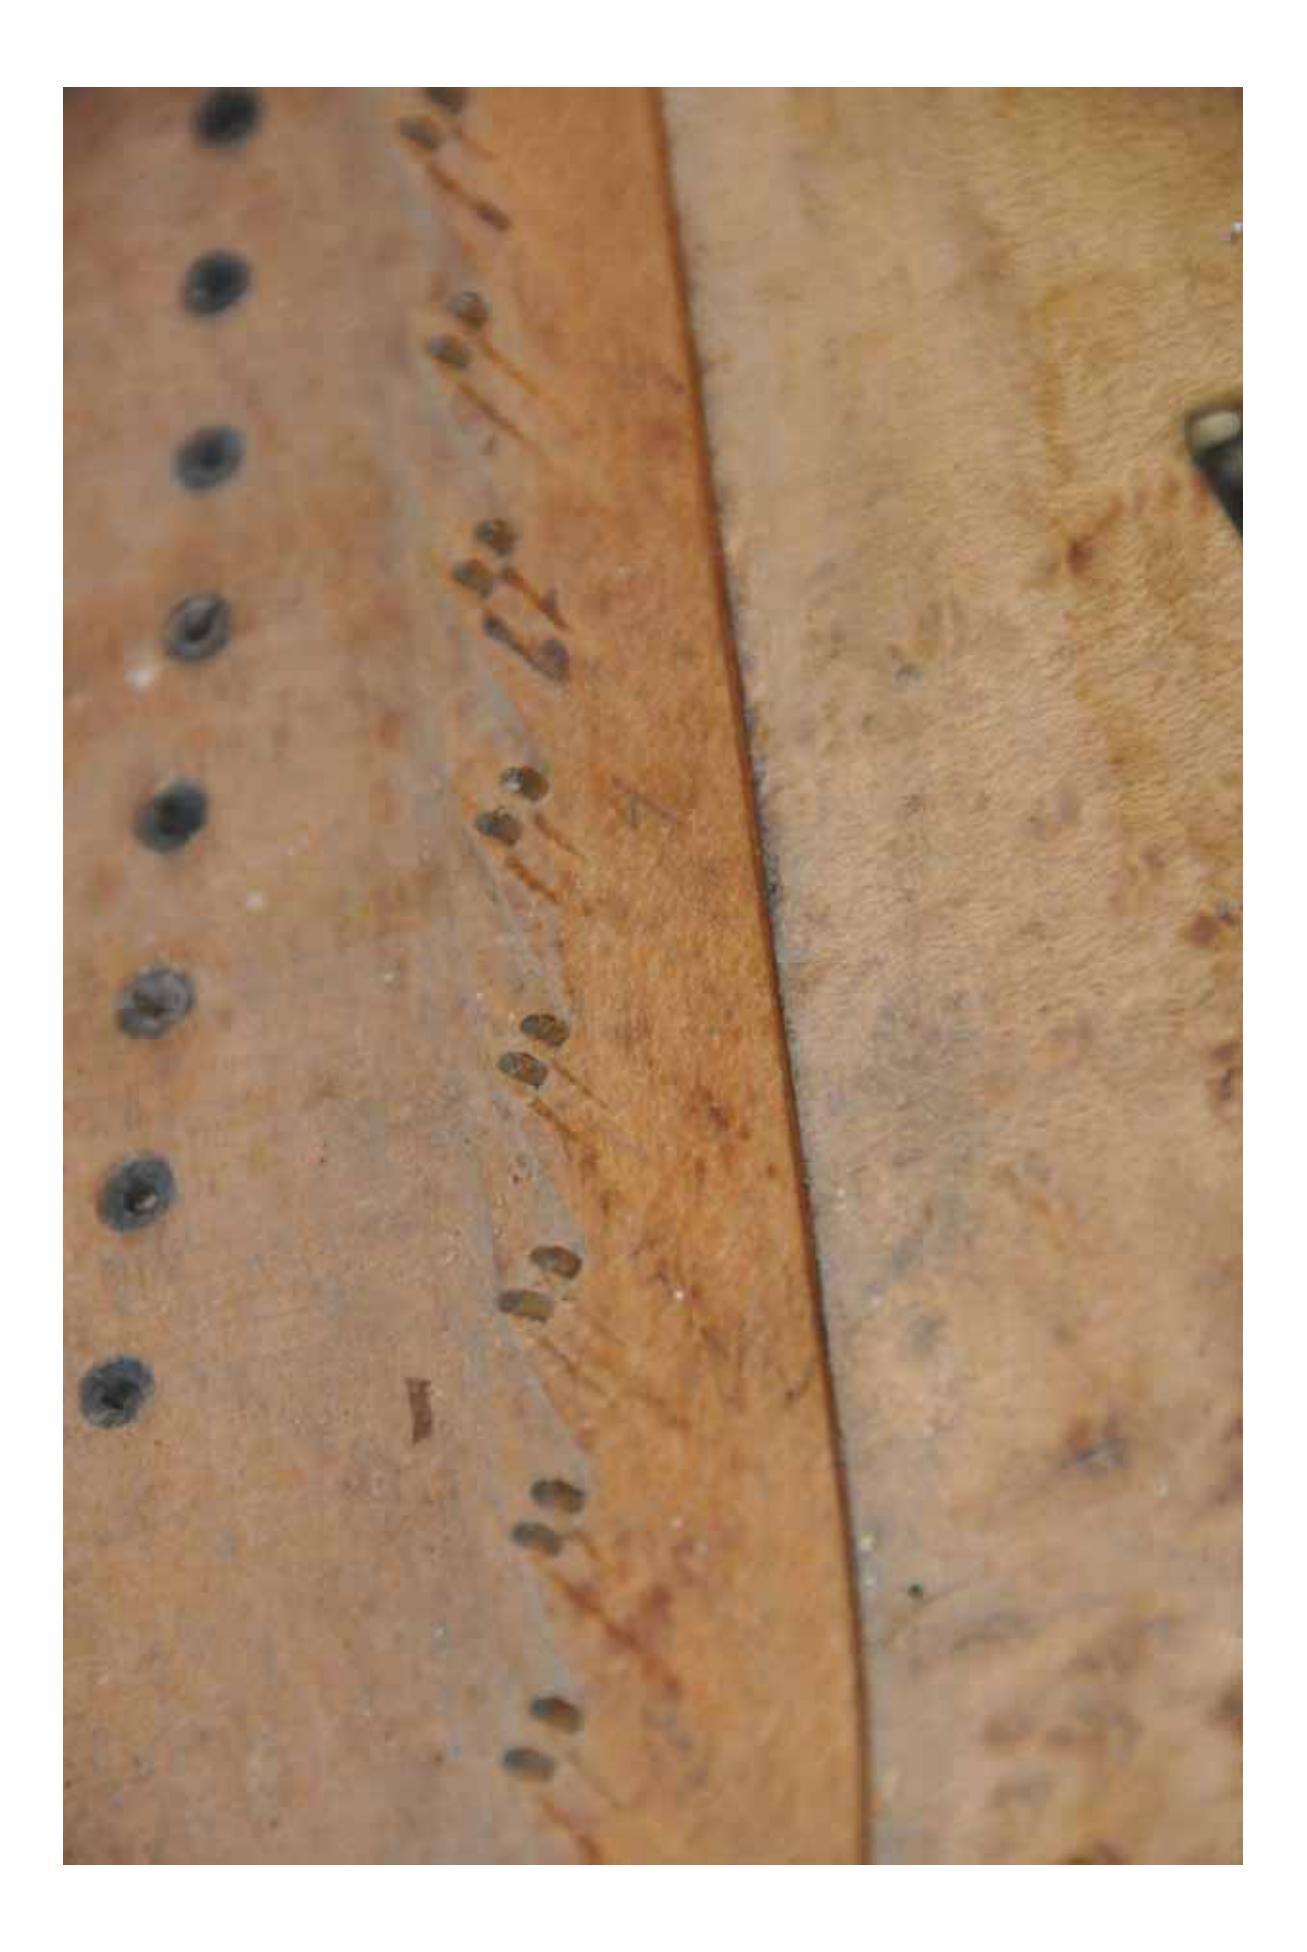
The nut was marked in pencil for German gauge diameters, though the marking had been obscured by decades of wear and cleaning. Enough could be made out, coupled with string diameters as-measured, to develop the original scaling.

The	'As-Found	d' measurements and n	narkings	
Number	Note	Length mm	Gauge	Number	Note	Length Gauge
1	FF	1420	7	41	a1	322
2	FF#	1407	6	42	a#1	304
3	GG	1390		43	b1	287
4	GG#	1376		44	c2	271
5	AA	1360		45	c#2	257
6	AA#	1342	6	46	d2	242
7	BB	1322	6 1/2	47	d#2	228
8	С	1310		48	e2	215
9	C#	1290		49	f2	204
10	D	1272	6 1/2	50	f#2	193
11	D#	1250	5	51	g2	182
12	Е	1230	5 1⁄2	52	g#2	174
			All above	53	a2	165
13	F	1207	5 1/2	54	a#2	159
14	F#	1180	4	55	b2	149
15	G	1152	5 1/2	56	с3	141
16	G#	1125		57	c#3	135
17	А	1098		58	d3	128
18	A#	1065		59	d#3	122
19	BB	1036		60	e3	115
20	С	1001	5 1/2	61	f3	109
21	C#	965	4 o	62	f#3	104
22	d	925		63	g3	96
23	d#	885	4 o	64	g#3	91
24	е	847	4 1/2	65	a3	84
25	f	811		66	a#3	79
26	f#	776		67	b3	74
27	g	740	4 1/2	68	c4	70
28	g#	702	3	69	c#4	65
29	а	664		70	d4	62
30	a#	627		71	d#4	59
31	b	588	3	72	e4	55
32	c1	548	3 1/2	73	f4	53
33	c#1	510				
34	d1	476				
35	d#1	447				
36	e1	424	3 1/2			
37	f1	403	2 o			
38	f#1	380

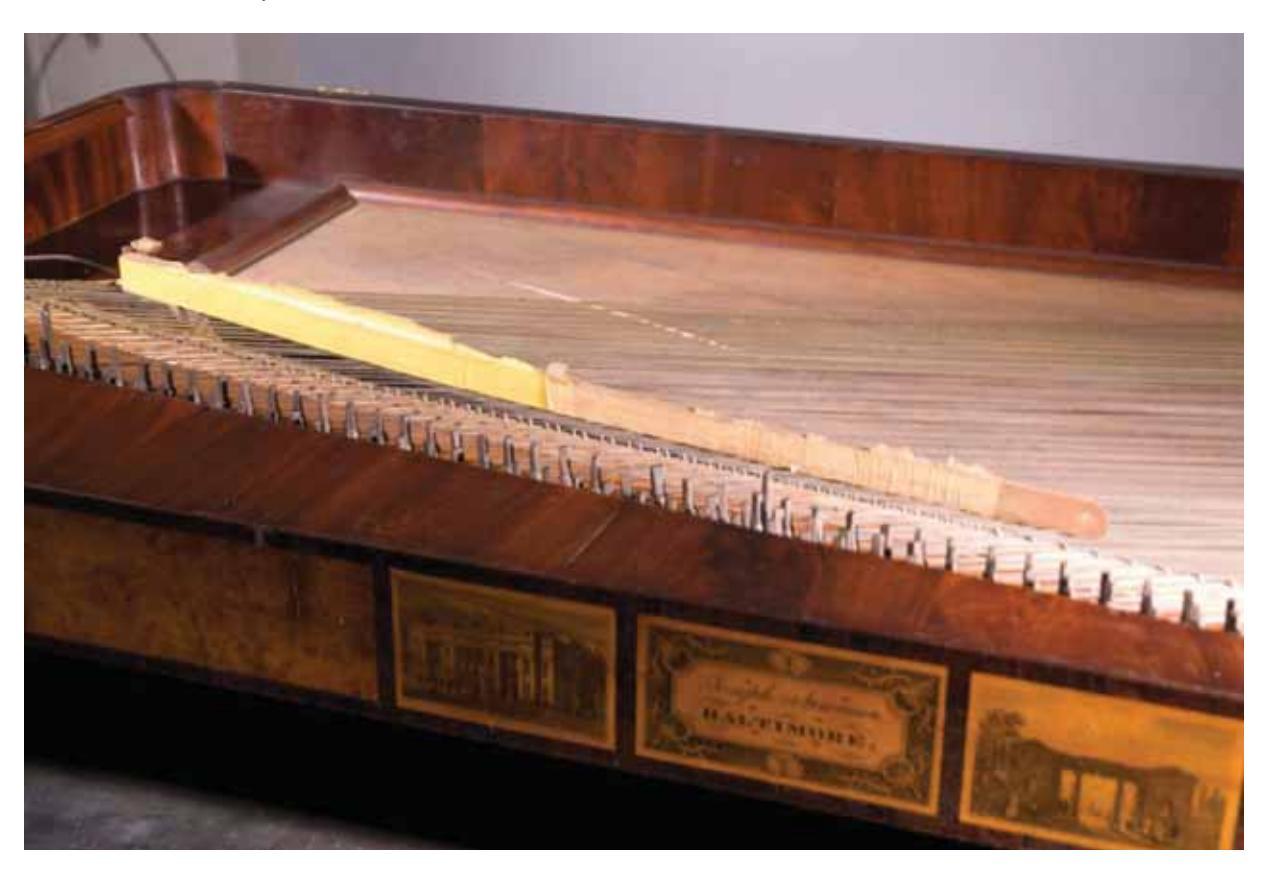
The bassoon stop was missing from the piano and was reconstructed based on an example still present in the Joseph Newman piano at Colonial Williamsburg. This is a sawn and tapering curved bar, attaching to the back of the wrest plank by a pivot screw, with the other end tilted up by a sticker rod activated by the pedal. The total travel of the bassoon stop is about 1 cm. The paper loop is formed of a stiff stock (in this case we formed it of a heavy marbled paper) and the height adjusted along the length of the bar such that as the bar is raised the paper meets the strings at about the same point down the length.
