Clementi Square Piano Number 8791

Collection of David Hackett, Chelveston, Northamptonshire

Restoration Notes – Part 1

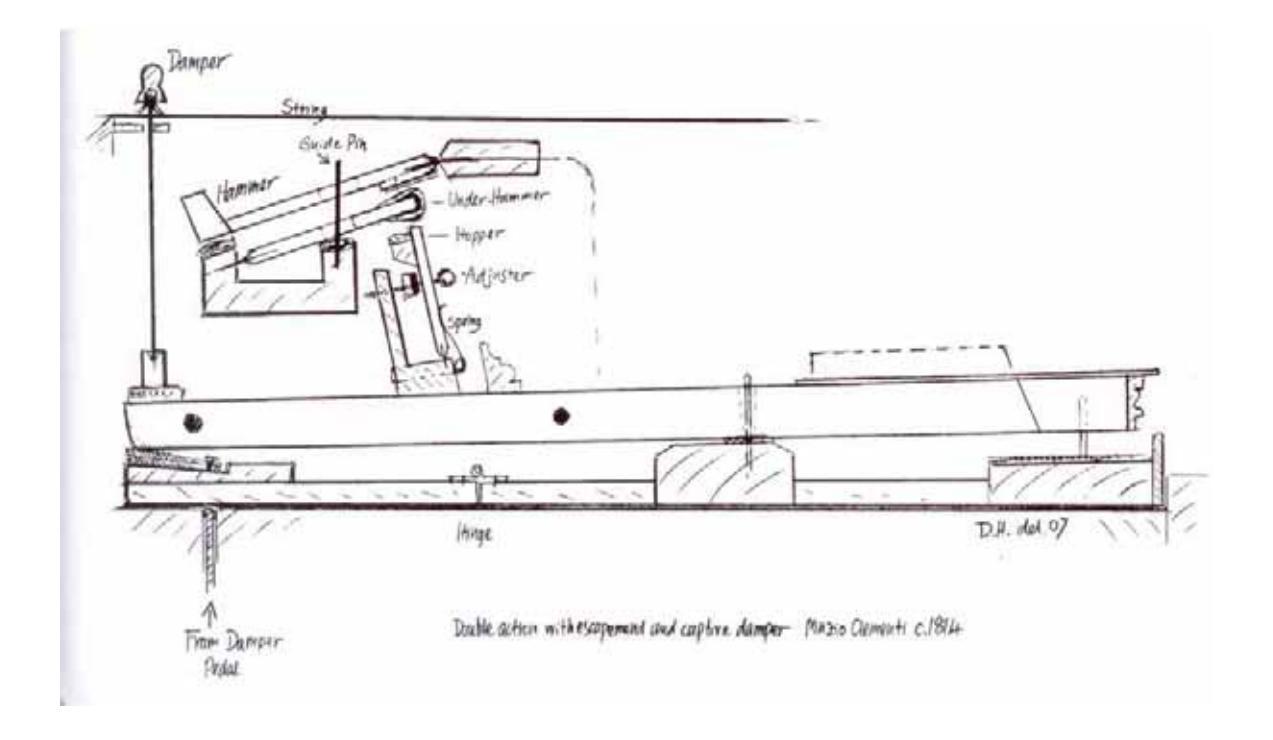
The action of this piano is based on Geib's patent escapement, for which Longman and Broderip purchased the rights. The use of this action gave their pianos a unique advantage, and this continued after Clementi took control. However, by 1812, when this piano was made, the patent had expired, and the action was in general use. It continued to be employed until the last English square pianos were made in about 1860.

Longman and Broderip were also quick to adopt Southwell's 'Irish Dampers', which replaced the clattery wooden lever dampers used the early English square pianos from Zumpe onwards. In the version used on this piano, the damper (which looks like a miniaturised version of an old-fashioned clothes-peg) is directly attached to the key lever, by way of a soft buff leather pad, a drilled lime-wood dowel, and a tinned brass wire. The soft leather pad is flexible enough to allow for the change in angle as the key is depressed. The system is light, direct, and quiet. Adjustment is effected by screwing the damper up or down in the dowel – the lower end of the wire is threaded. So far, so good.

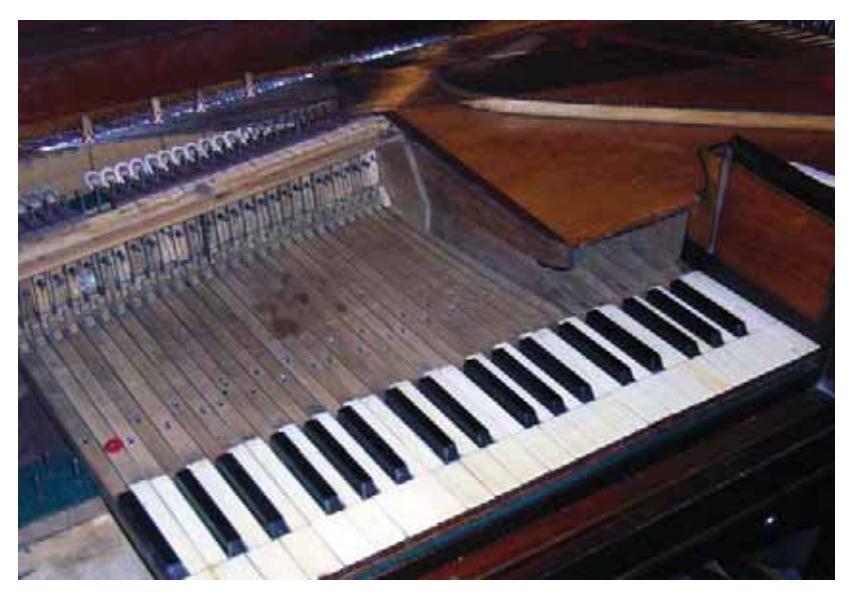
The problem starts when we try to arrange for a 'damper lift' pedal – as pianists were expecting by the early 1800s. The back third of the keyframe is hinged, and two rods operated by the pedal, and passing through the base-board, lift up this part of the frame, and with it the rear ends of the keys. This lifts the dampers away from the strings as intended -a spring (not shown) reverses the movement when the pedal is released. The snag is, of course, that this arrangement also causes the front of the keys to dip, and the player may find this somewhat disconcerting. This does not apply to the top notes, which have no dampers, so those keys stay where they are! Also, if the escapement is to reengage properly when the keys are in this position, there has to be a certain amount of free-play or 'lost motion' when the pedal is not depressed. This sounds less than ideal, but it seems to be working out quite well in practice. The trick seems to be to adjust the dampers carefully and evenly, and then arrange for the pedal to lift them just clear of the strings. Once the dampers are in place, the action cannot be taken out for further adjustment without removing them again, so a policy of 'right first time' is being adopted. The key frames are firmly screwed down, and working downwards from the top means that the hammers can be removed, re-hinged, re-covered, and replaced without the strings getting in the way. The new strings for each note are put in place as the corresponding hammer is put back.

One more thing has changed; in Part 1 we started to re-cover the hammers with deerskin; there was evidence from remnants underneath the felt that this material had been used before. This sounded OK for the top notes, but after about an octave and a half (down from the top) the tone was starting to sound a bit dull. So a switch was made to a firmer vegetable-tanned goatskin (also from Harmaton Leathers), and the top notes done again. This is giving a dramatically better and brighter tone in the treble.

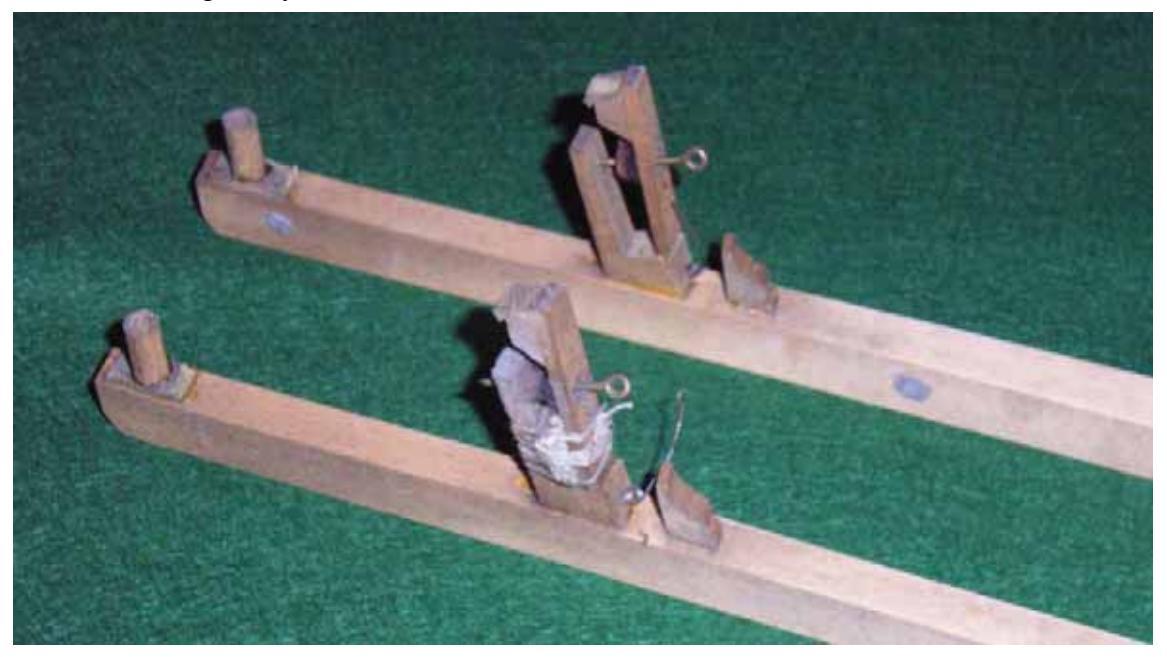
As we move on to the middle part of the compass, several of the action parts need attention. As we see in the picture, a few of the vellum hinges which allow the escapement hoppers to move have failed at some time in the past, and have been repaired with more ingenuity than skill!

The nearer one in the picture has been repaired with a wadge of newspaper, bound with cotton. Our good friend Graham Gadd (author of 'The British Art Piano and Piano Design') - who had a distinguished career in Journalism - has identified the scraps of paper as mid-to-late nineteenth century, which is probably the time at which the hammers were covered with felt. Presumably the system worked more or less, as there is a certain amount of 'give' in the joint. However, more authentic replacement vellum hinges have been substituted now!

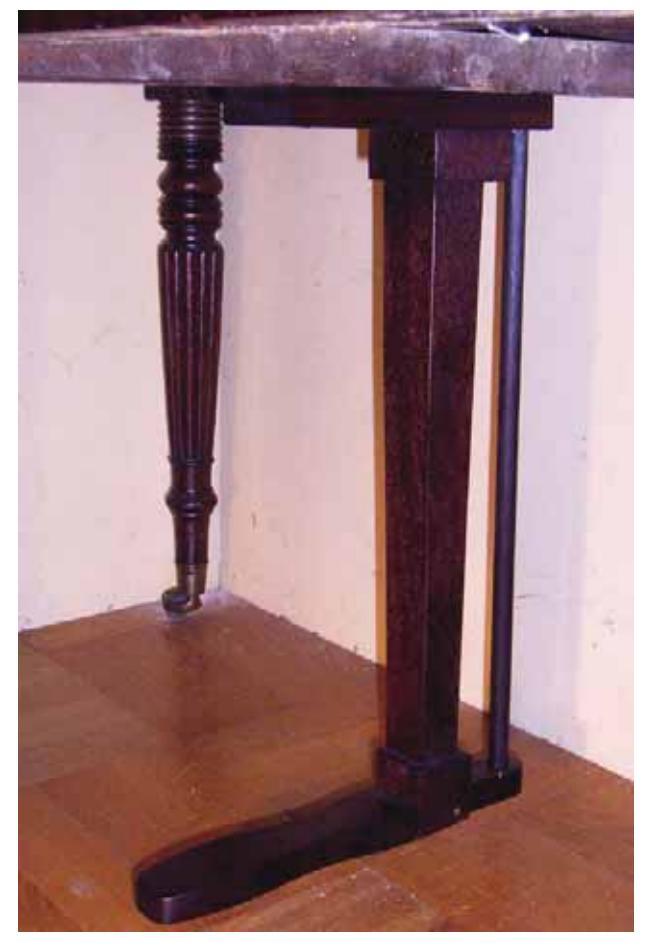
Missing pedal-legs are very common on surviving early square pianos. There is no doubt that the original in this case was a turned and reeded leg, like the one in the background. The remnants of the tapped thread in the stand confirm this. Now, at a push, I could manage the turning, but the reeding bit is something else, and I have other things to do (like feeding the cats and shopping). So, this piano now has a rectangular-section pedal leg (there are plenty of precedents for this, by the way). The good thing is that I have got the gearing ratios about right, so it works properly!

The time has come to re-instate the pedal and its mechanism, and to relate this to the action.

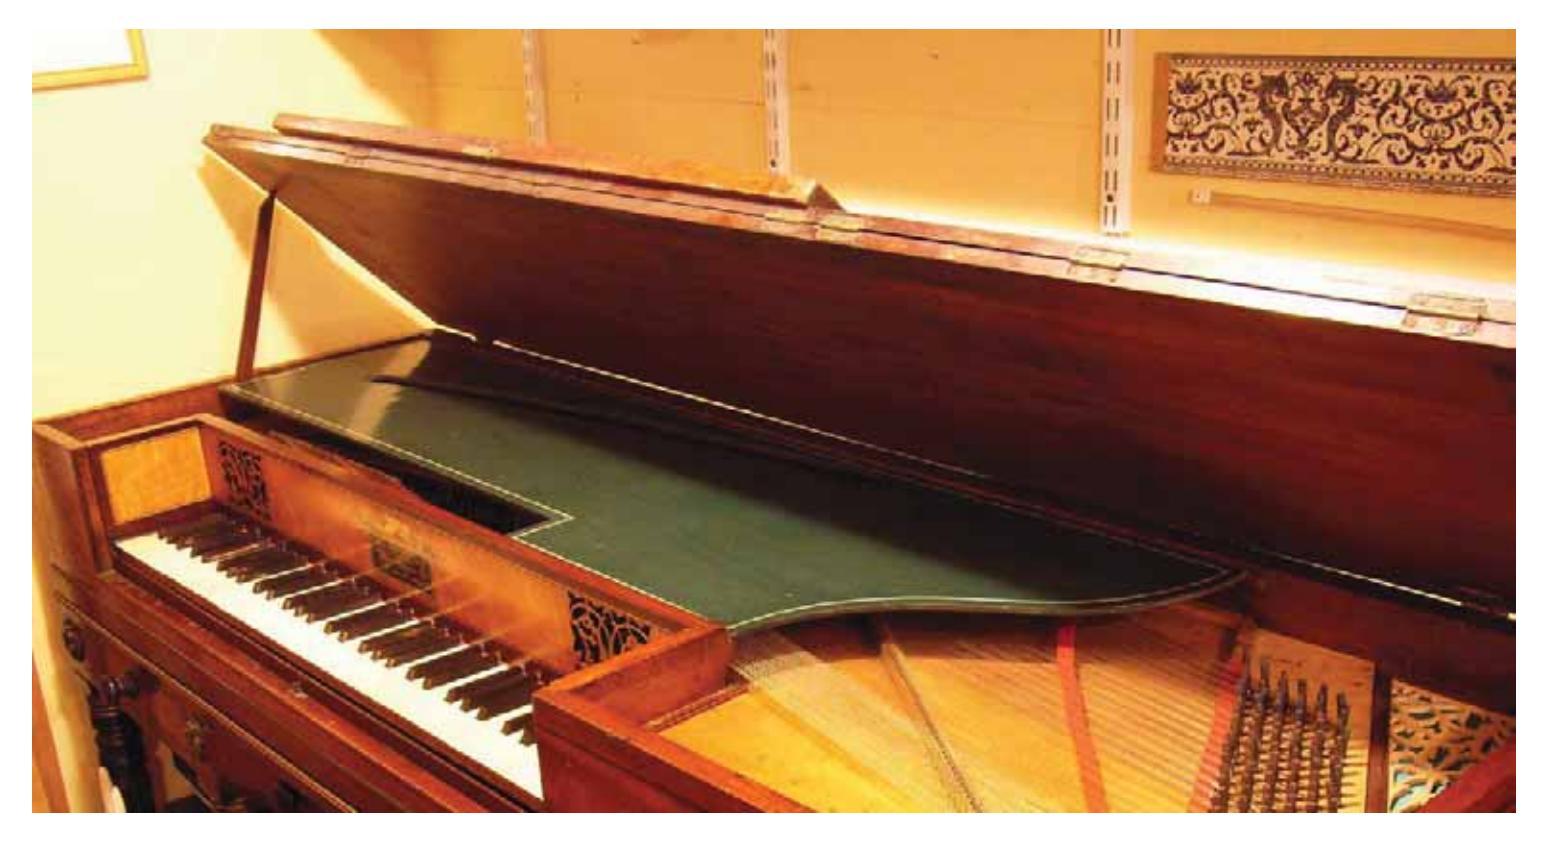
The green 'dust cover' on this piano has fortunately survived, and is now back in place. The piano is now starting to hold its tune well, and I have now made my first attempt to play some of Clementi's charming Sonatinas. The highlight of the restoration was on February 18th, when Jeremy Eskenazi, founder of The Clementi Society, came to visit, and we were able to enjoy listening to this lovely little piano being played properly!

There were a few little problems: several of the damper bodies – the 'Dollies' were missing, and quite a few more of the damper wires fractured when being re-fitted or adjusted. The bass damper wires in particular can easily rattle against the strings – a problem which needs a gentle double-bend to keep the wire clear of the string. The original wires were made of tinned brass, about 0.85mm diameter; finding tinned brass was tricky, but Malcolm Rose kindly supplied a few metres of tinned copper. This proved ideal for the job, and putting the threads on the bottom ends was surprisingly easy, by cutting the thread with a wallpaper scraper in a rolling action. It's always nice when something works better than expected!
